The authenticity and integrity of the Historic Monuments Zone of Querétaro

**Cultural Heritage and Sustainability:
Querétaro as case study**

Research as part of the graduation studio 'Cultural Heritage and Sustainability: World Heritage cities as case study', as part of a research on sustainable development, carried out by the AUDE Unit (Architectural Urban Design and Engineering) of the Eindhoven University of Technology (TU/e).

Historic Monuments Zone of Querétaro, Santiago de Querétaro, Mexico

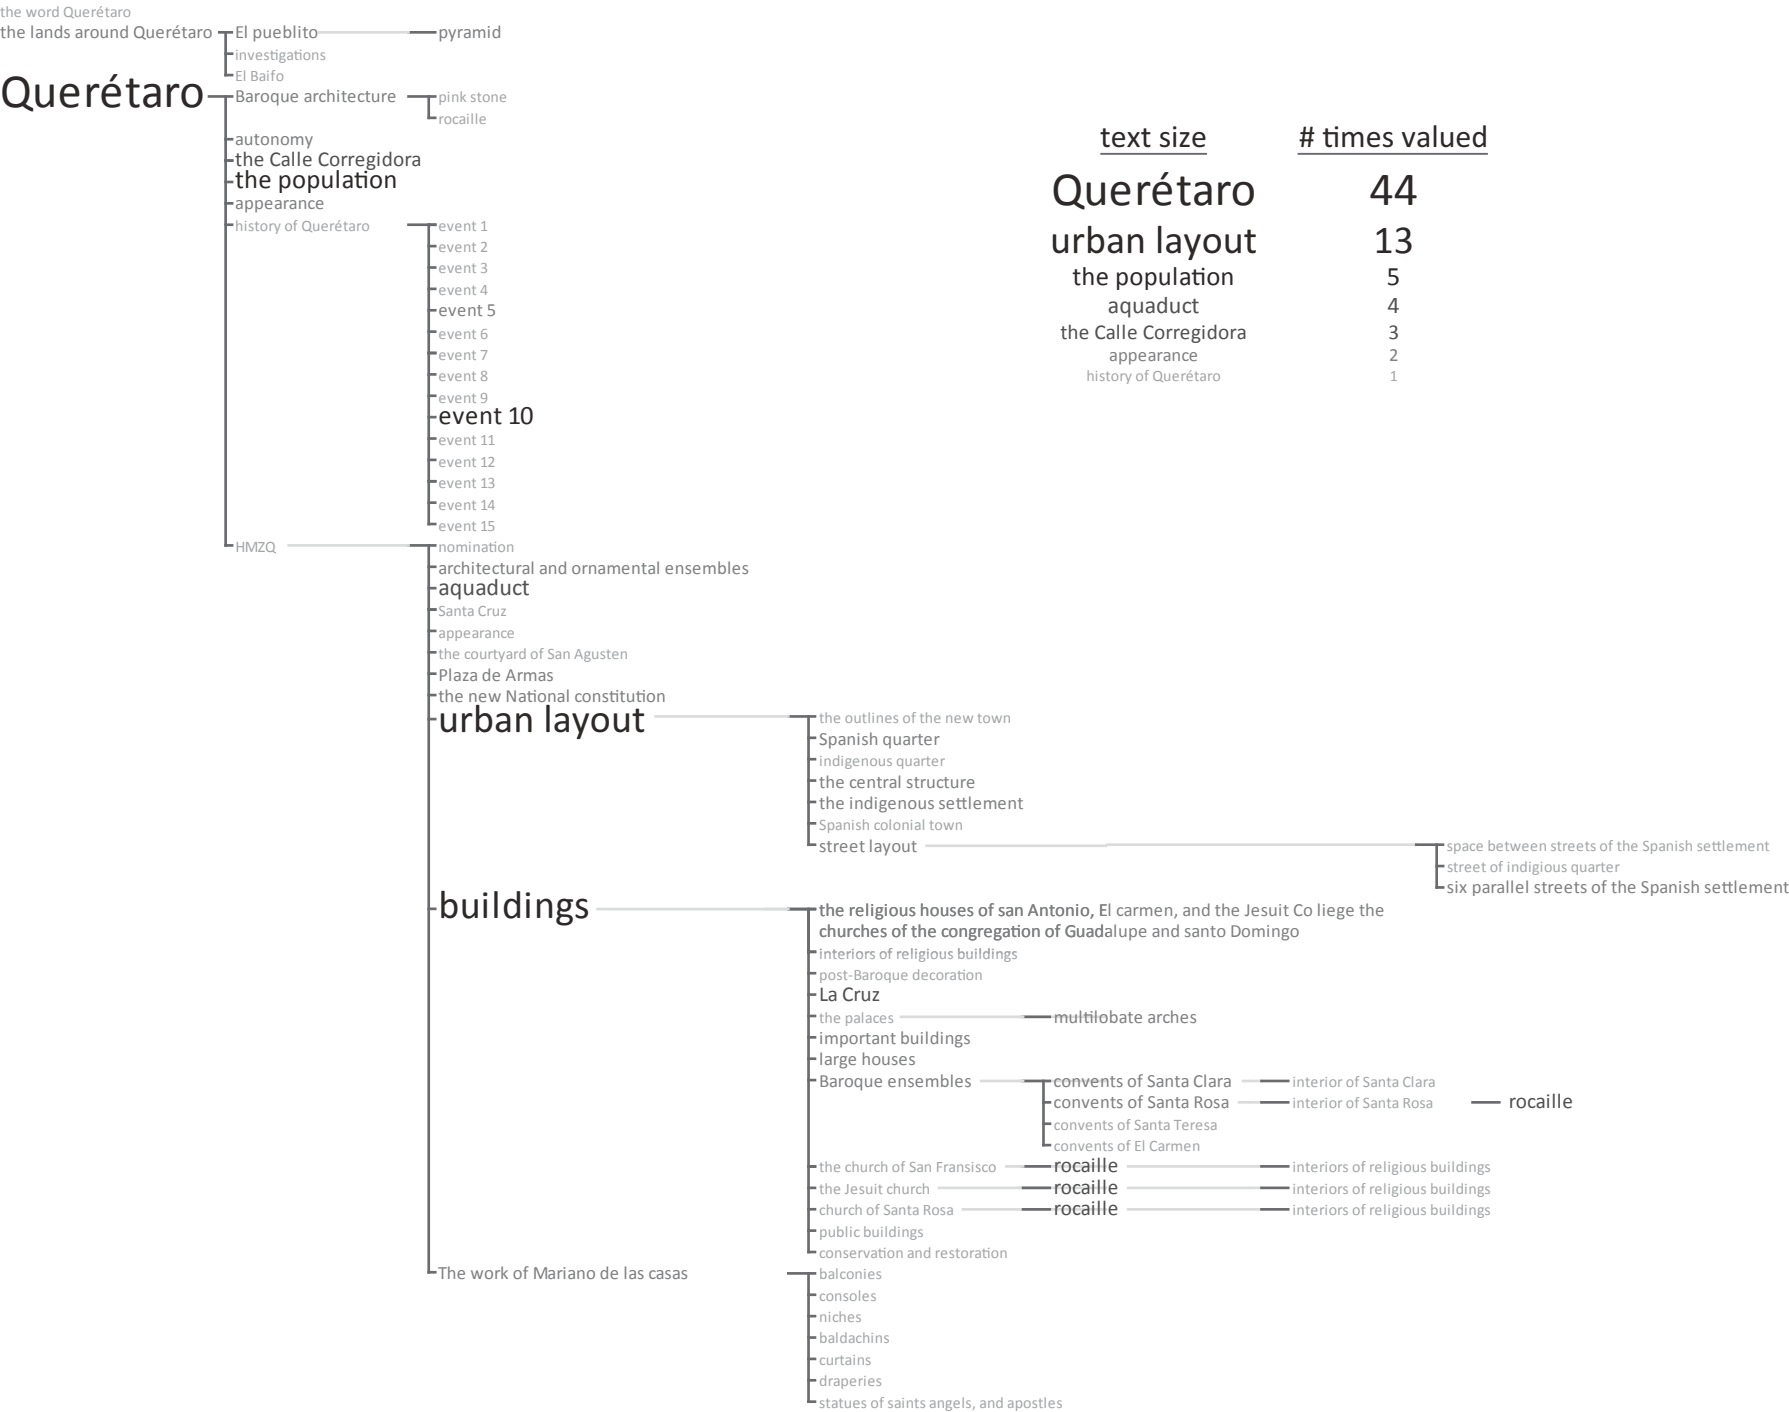
figure 02. Attribute and sub attribute scheme, ABE

In the ABE, which contains 7 pages, 78 attributes that were valued at least once were found. Those attributes are presented within their classification of hierarchy in figure 02. The biggest category in the highest hierarchy is "Querétaro". This is the city itself. It is noticeable that this category is mentioned a lot while parts of Querétaro are not within the protected zone. A similar situation occurs for "the lands around Querétaro". These lands get valued, but are not described as being part of the protected zone, described as the "HMZQ".

The HMZQ exists within the second level of hierarchy classification. Although the attribute itself is valued less than other attributes within the classification (shown small in figure 02), there are a lot of sub classifications within this category.

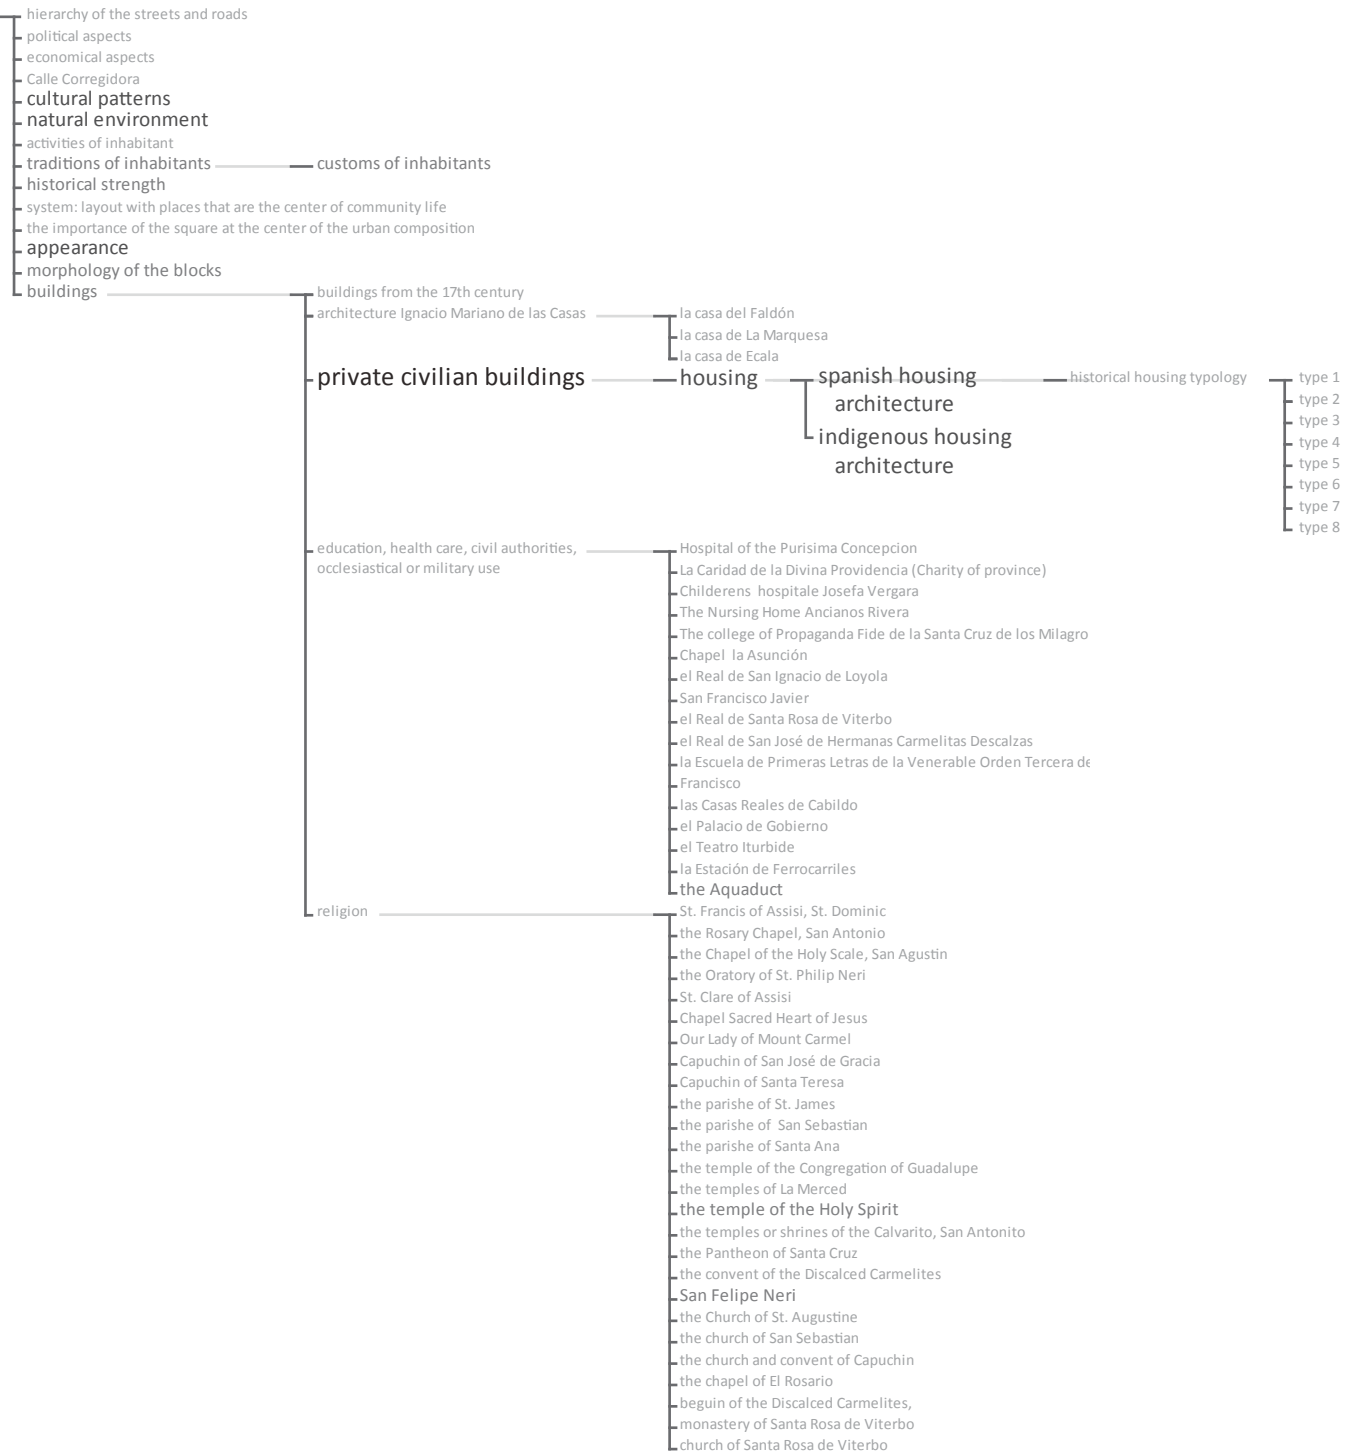
figure 03. Attribute and sub attribute scheme, Management Plan

In the MP, which contains 331 pages in 6 chapters, 157 attributes that were valued at least once were found. Those attributes are shown within their classification of hierarchy in figure 03. Again the category "Querétaro" in the highest level of hierarchy is valued more than average (shown bigger in figure 03), but now it is the only attribute within this category.

The HMZQ exists within the second level of hierarchy classification. Now, this attribute is valued relatively more than other attributes (shown big in figure 03) and there are a lot of sub classifications within this category.

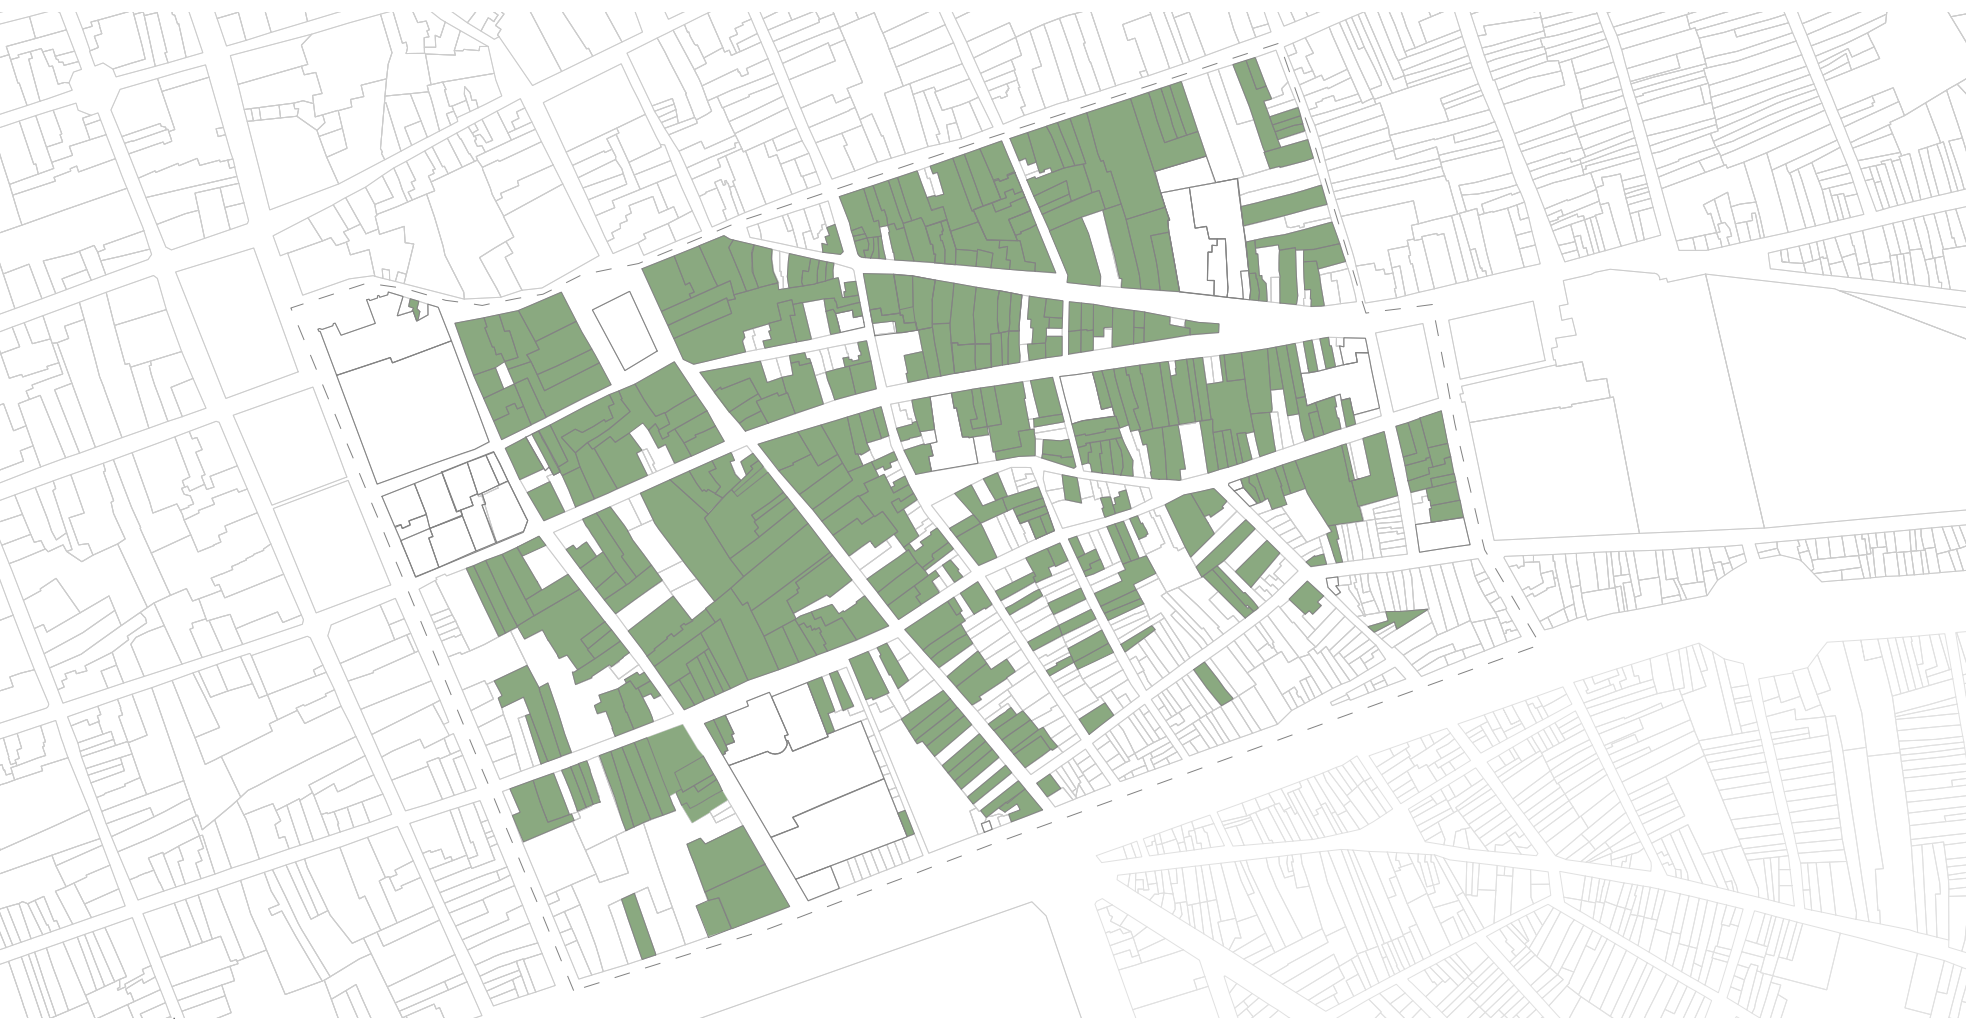
map 04. Overview of the catalogued
buildings, sector G

There are 31 building blocks in sector G from which two (blocks 41 and 48) have no catalogued buildings. There are 854 buildings in this sector, but data from 1990 and/or 2000 is not available for all of them. All the buildings catalogued in 1990 and/or 2000 that were originally residential, in sector G, are shown in map 04. These buildings have been researched in the field.

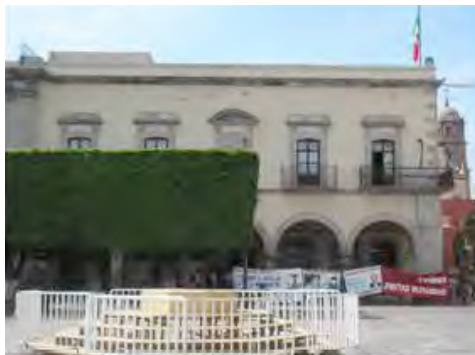
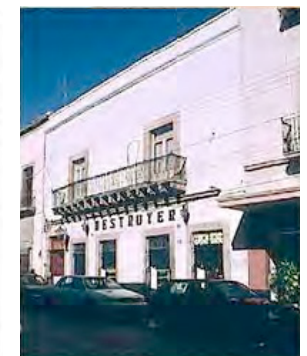
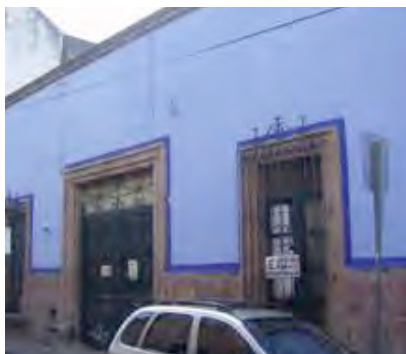
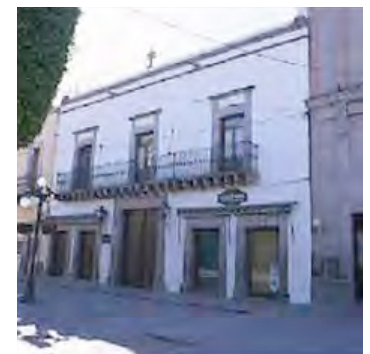
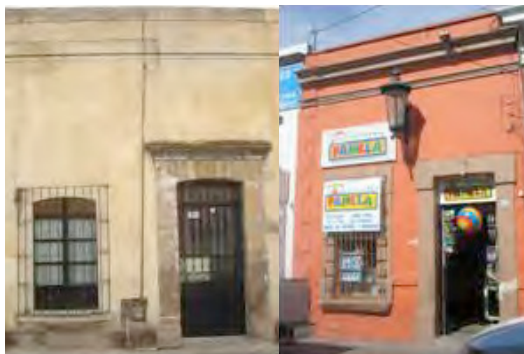
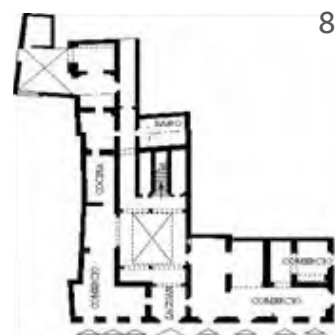
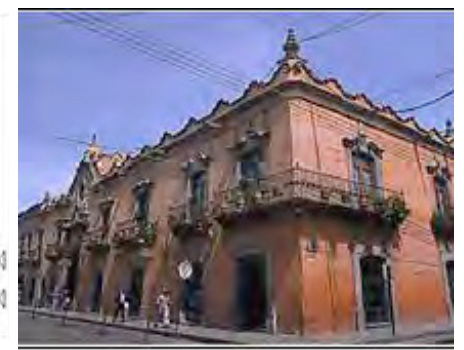
figure 03. Housing types - photos and floor plan (source: IMPLAN, 2012)

façade. Mostly the houses of this kind also present one or two patios at the back of the house.

Type 8 comprises all houses in which the architectural plans present special or different characteristics, and therefore cannot be included in any of the abovementioned typologies.

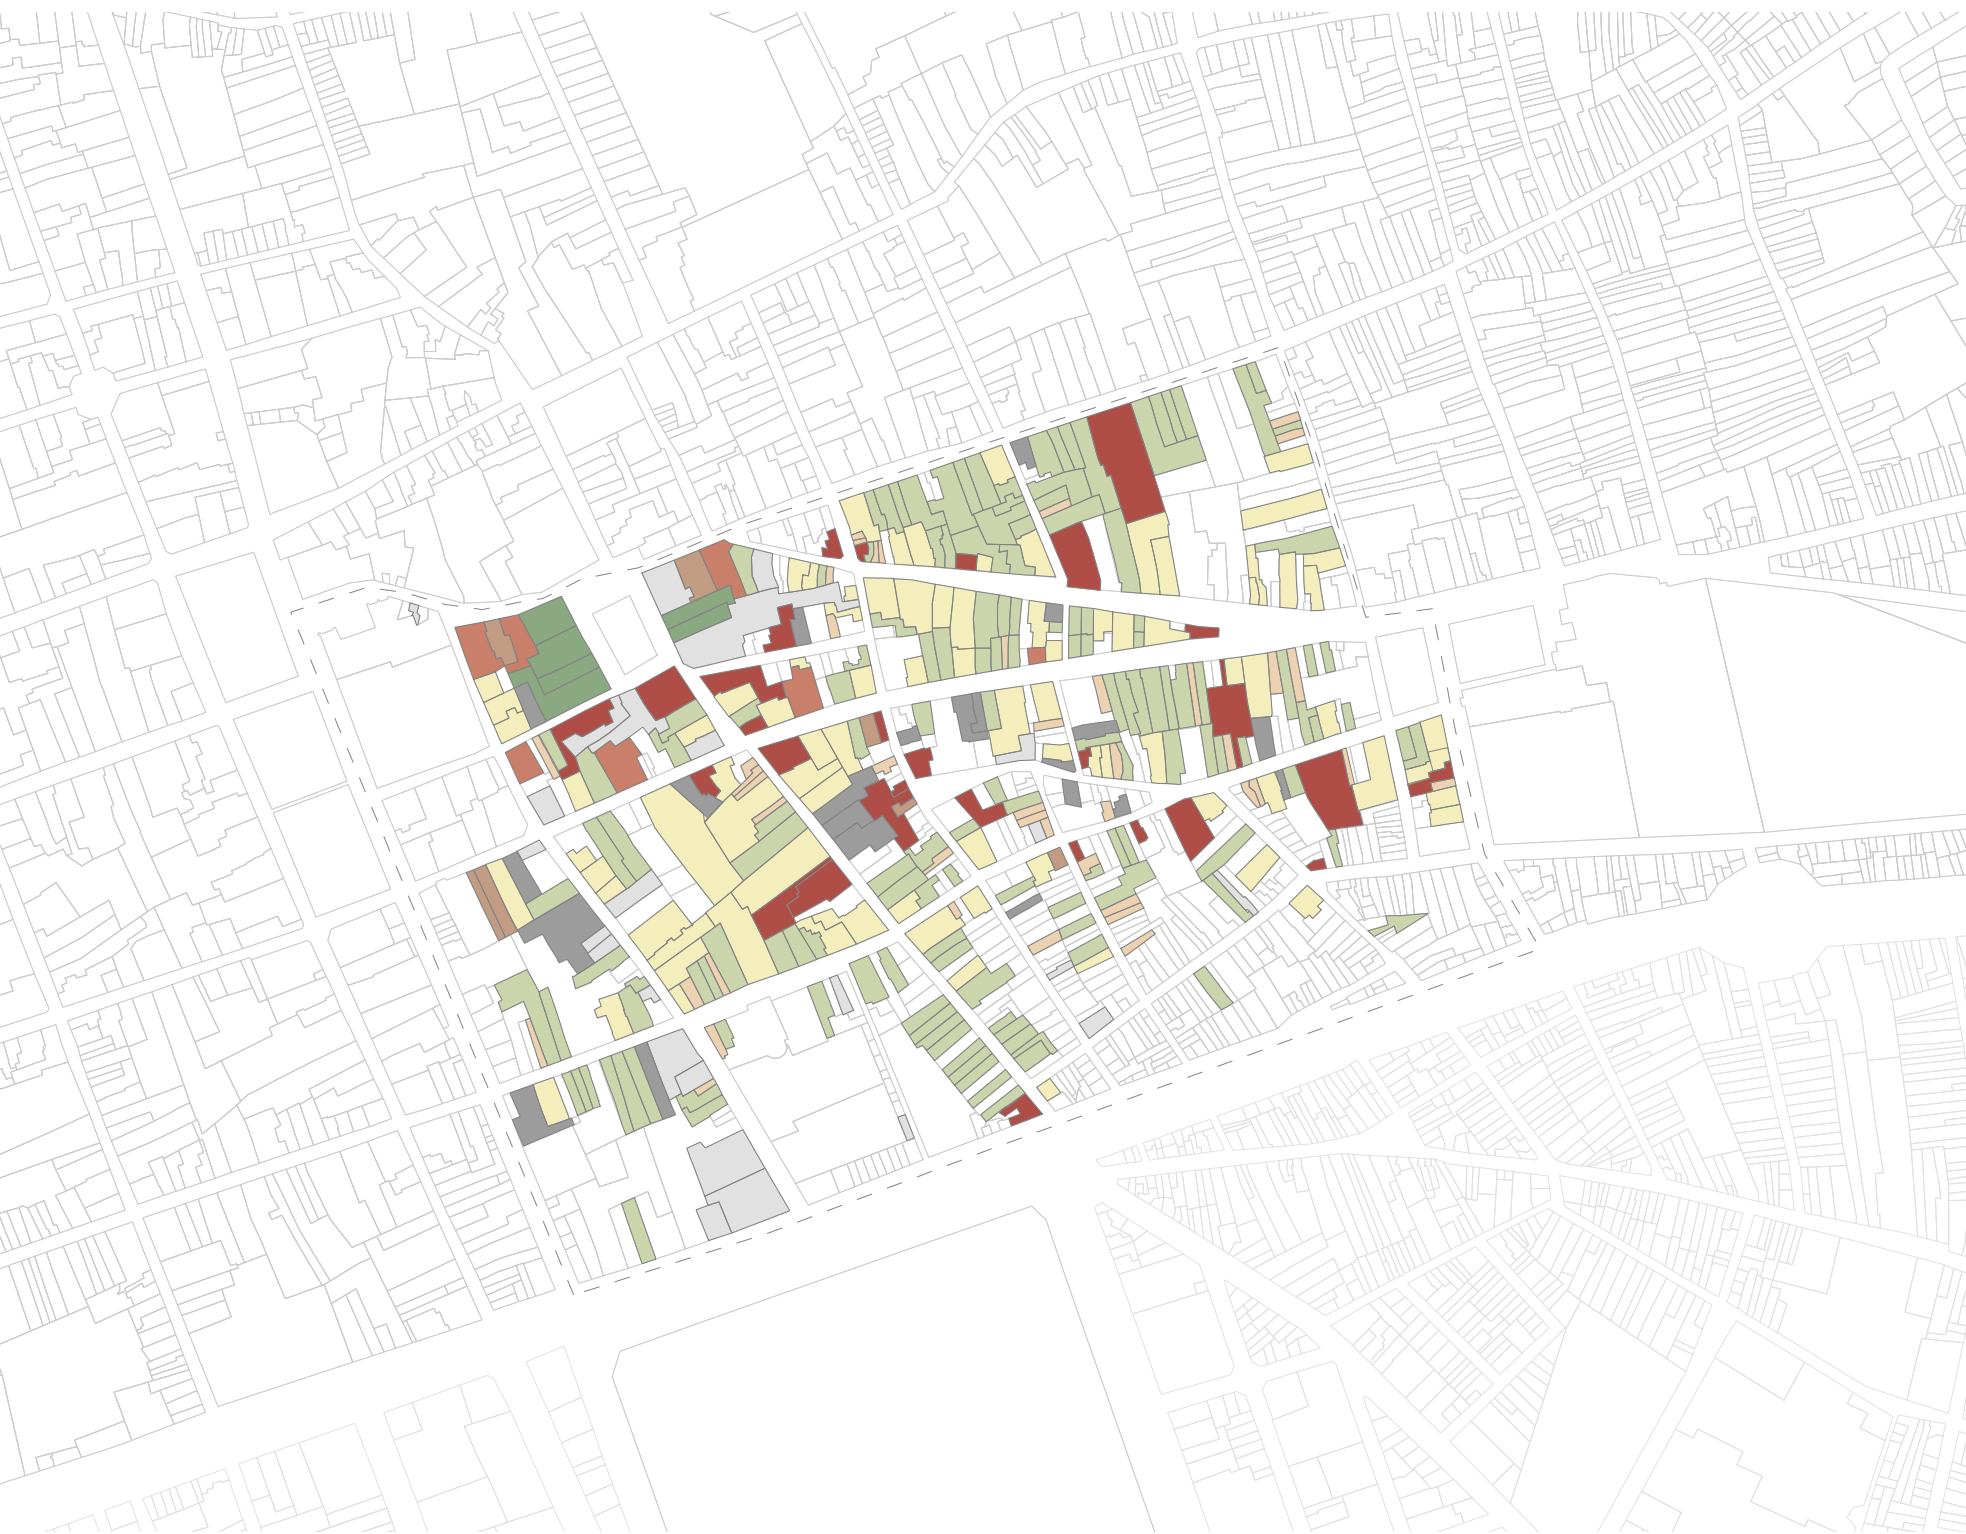
map 05. Housing typologies of sector G
1:5000

Types	% of houses
Type 1	1.7 %
Type 2	40.1 %
Type 3	24.3 %
Type 4	11.4 %
Type 5	0.0 %
Type 6	1.9 %
Type 7	1.9 %
Type 8	8.4 %
No access, no valid type	10.3 %
Total	100 %

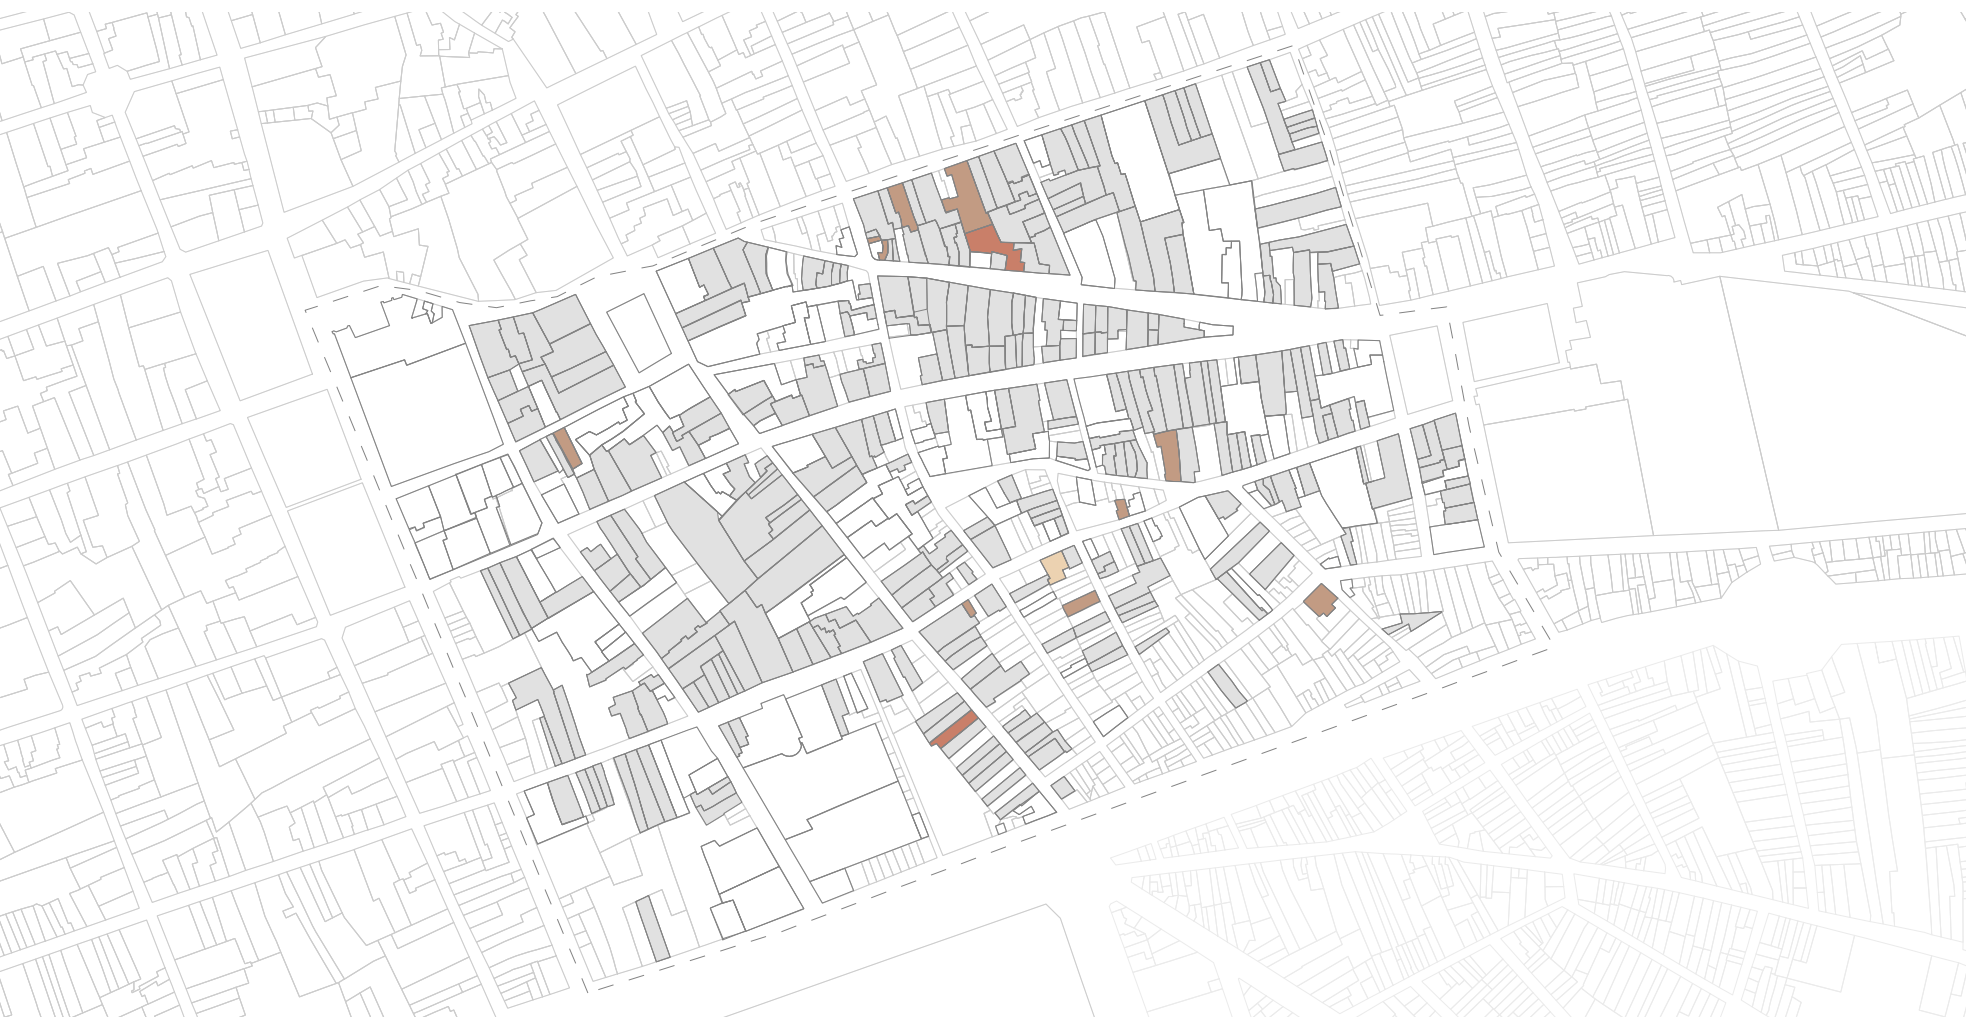
Changes in attribute: stories

Map 10 reveals the changes in the number of stories through time showing that there are no significant changes regarding the building height in the research area. Of all 13 changes that have occurred (one between 1990 and 2000, ten between 2000 and 2013 and two in both periods, covering 4.4% of all buildings with specified number of stories), 11 are located in the middle or east half of the research area. In seven cases an extra floor has added to the building, in one case one floor is removed and the

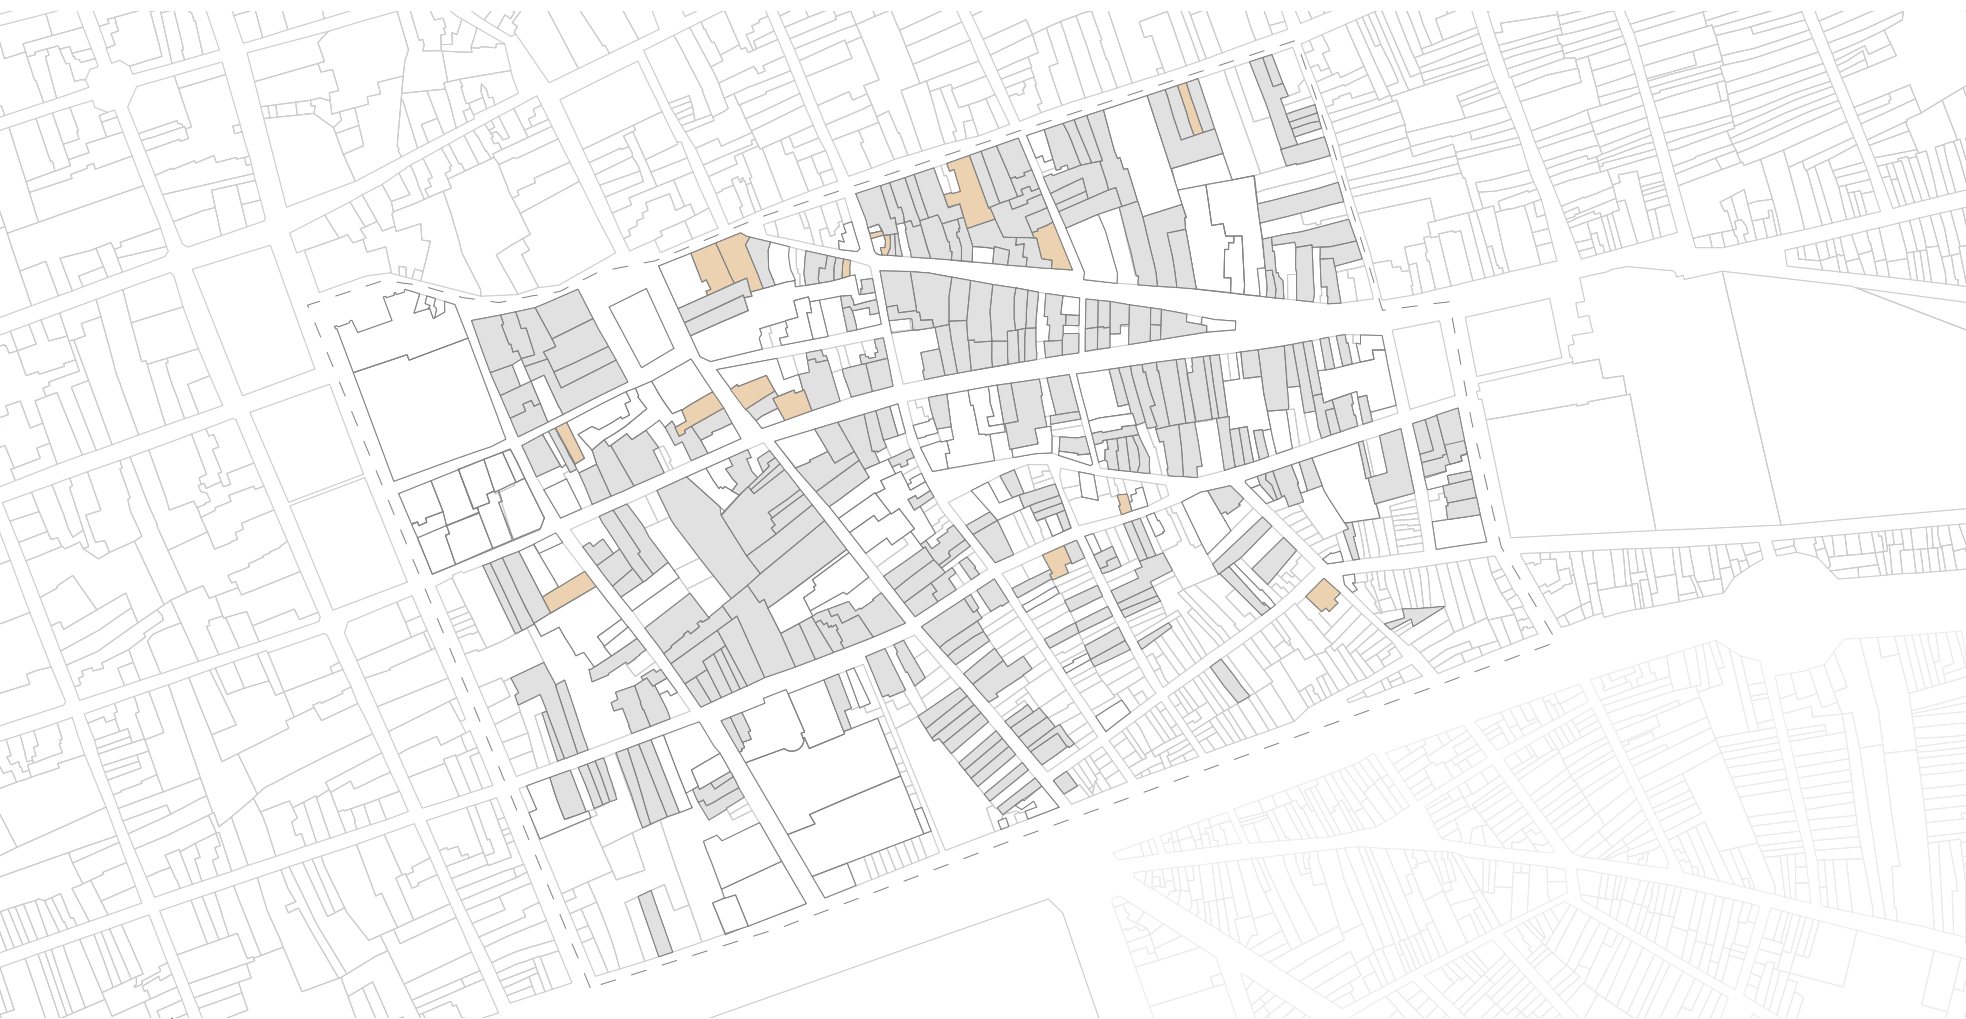
map 12. typology comparison: stories

Comparing the actual number of the stories in 2013 with the ideal state of this attribute reveals that of 298 buildings analyzed in this part, 16 (5.4%) have changed in number of stories in comparison to what is shown in the ideal state. Among the 16 buildings not corresponding to the typology, nine cases were altered in height between 1990 and 2013.

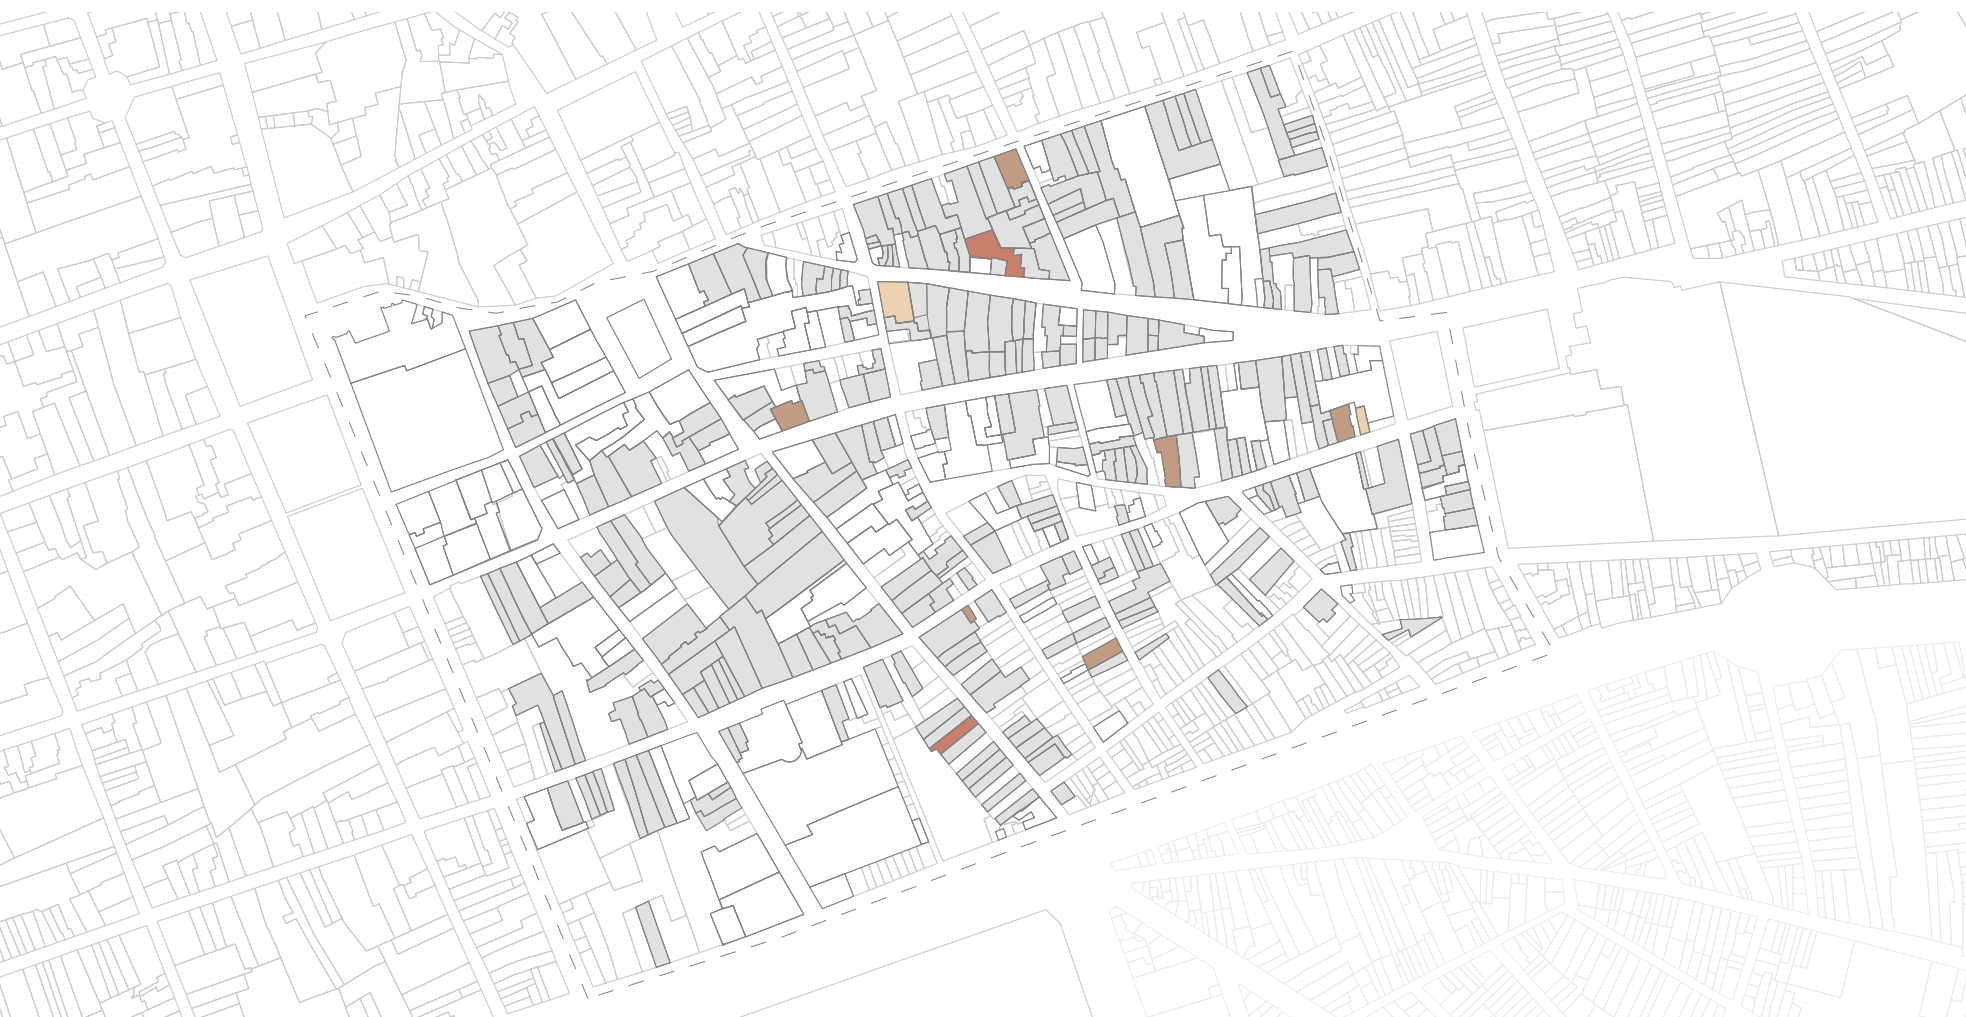
Changes in attribute: entrance

In total, ten of 292 houses (3.4%) have changed over time in terms of the entrance. Among those ten changes, two have occurred between 1990 and 2000, six between 2000 and 2011 and two in both periods. In three cases, a door has been added to the building and in two cases a door has been removed. In six cases a door has altered and in one case the door has changed into a window.

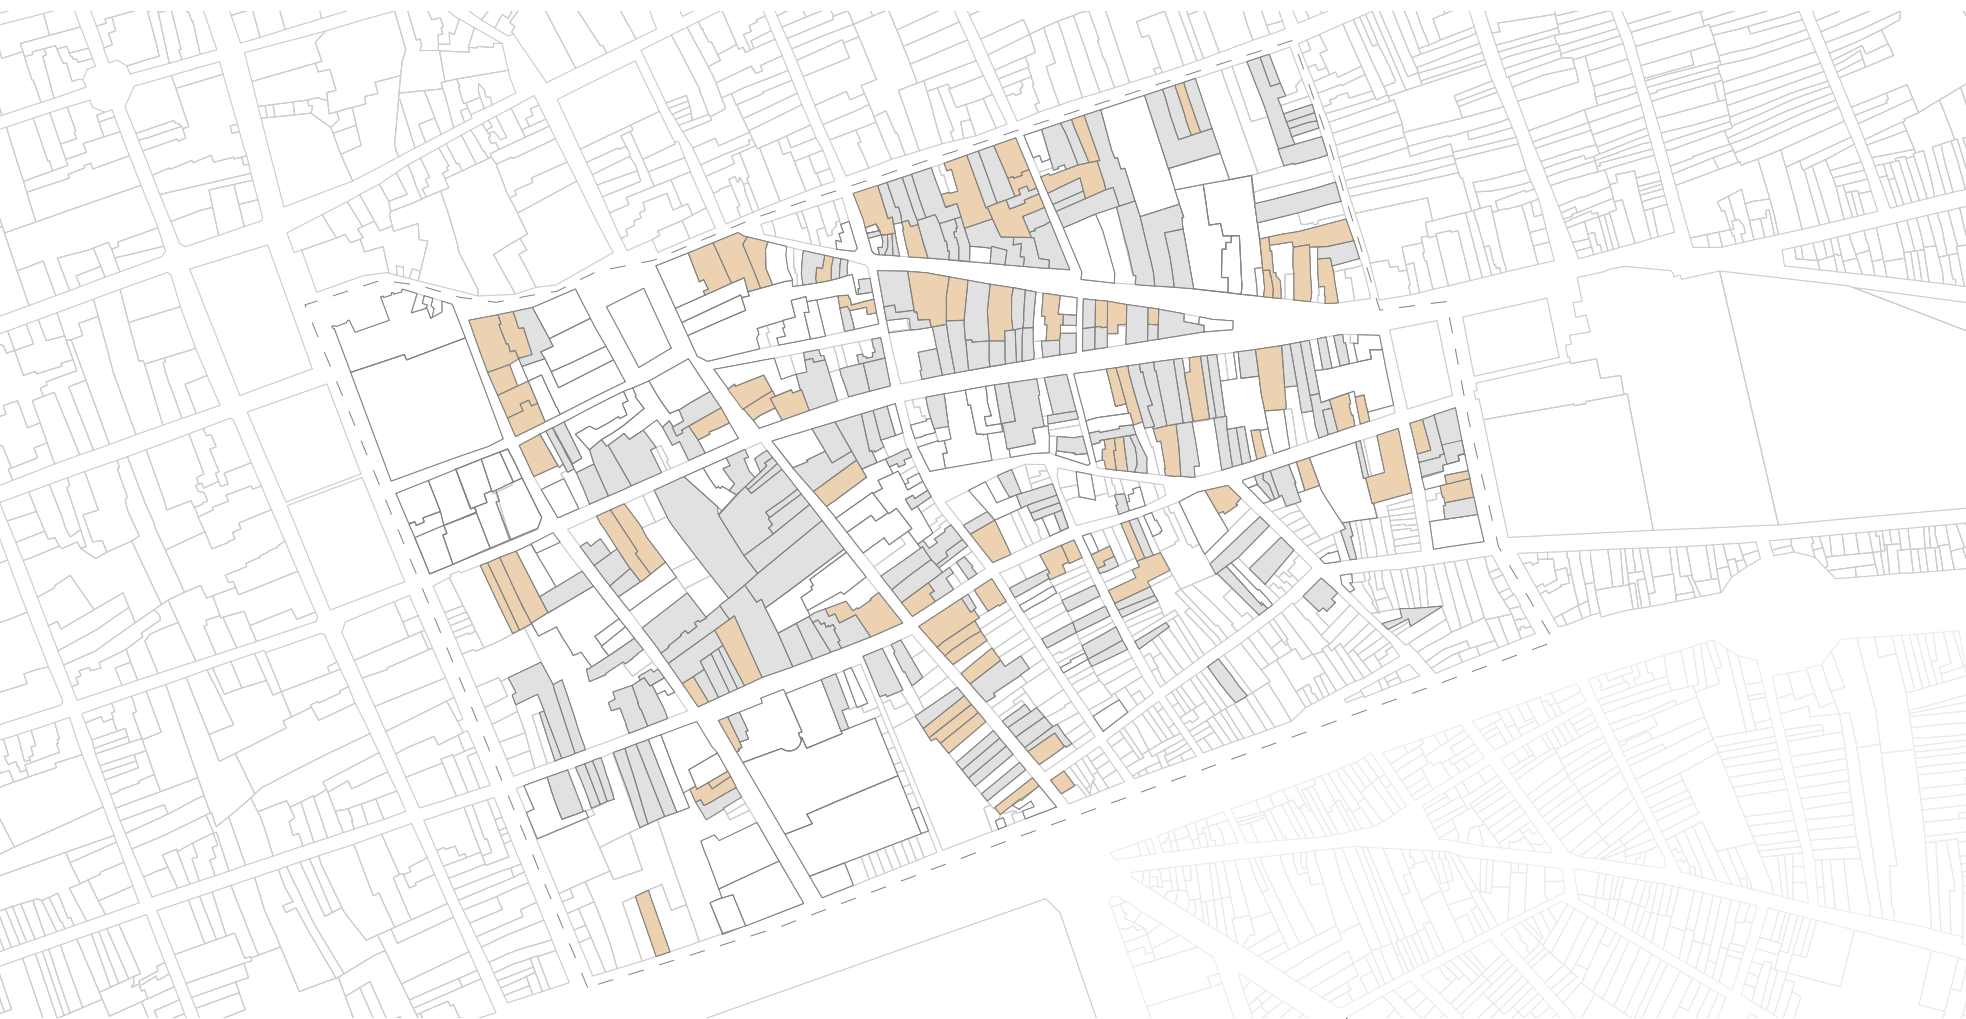
The state of the entrances in 2013 is compared with the ideal state. The result of this comparison is illustrated in map 19, showing that of the 292 houses studied in this part, 85 (29.1%) do not fit the typology description in terms of entrance type and are equally spread in the whole studied area. A comparison between map 19 and map 18 reveals that 7.1% of the buildings that do not correspond with the typology, have changed over time, and therefore in the remaining buildings the change

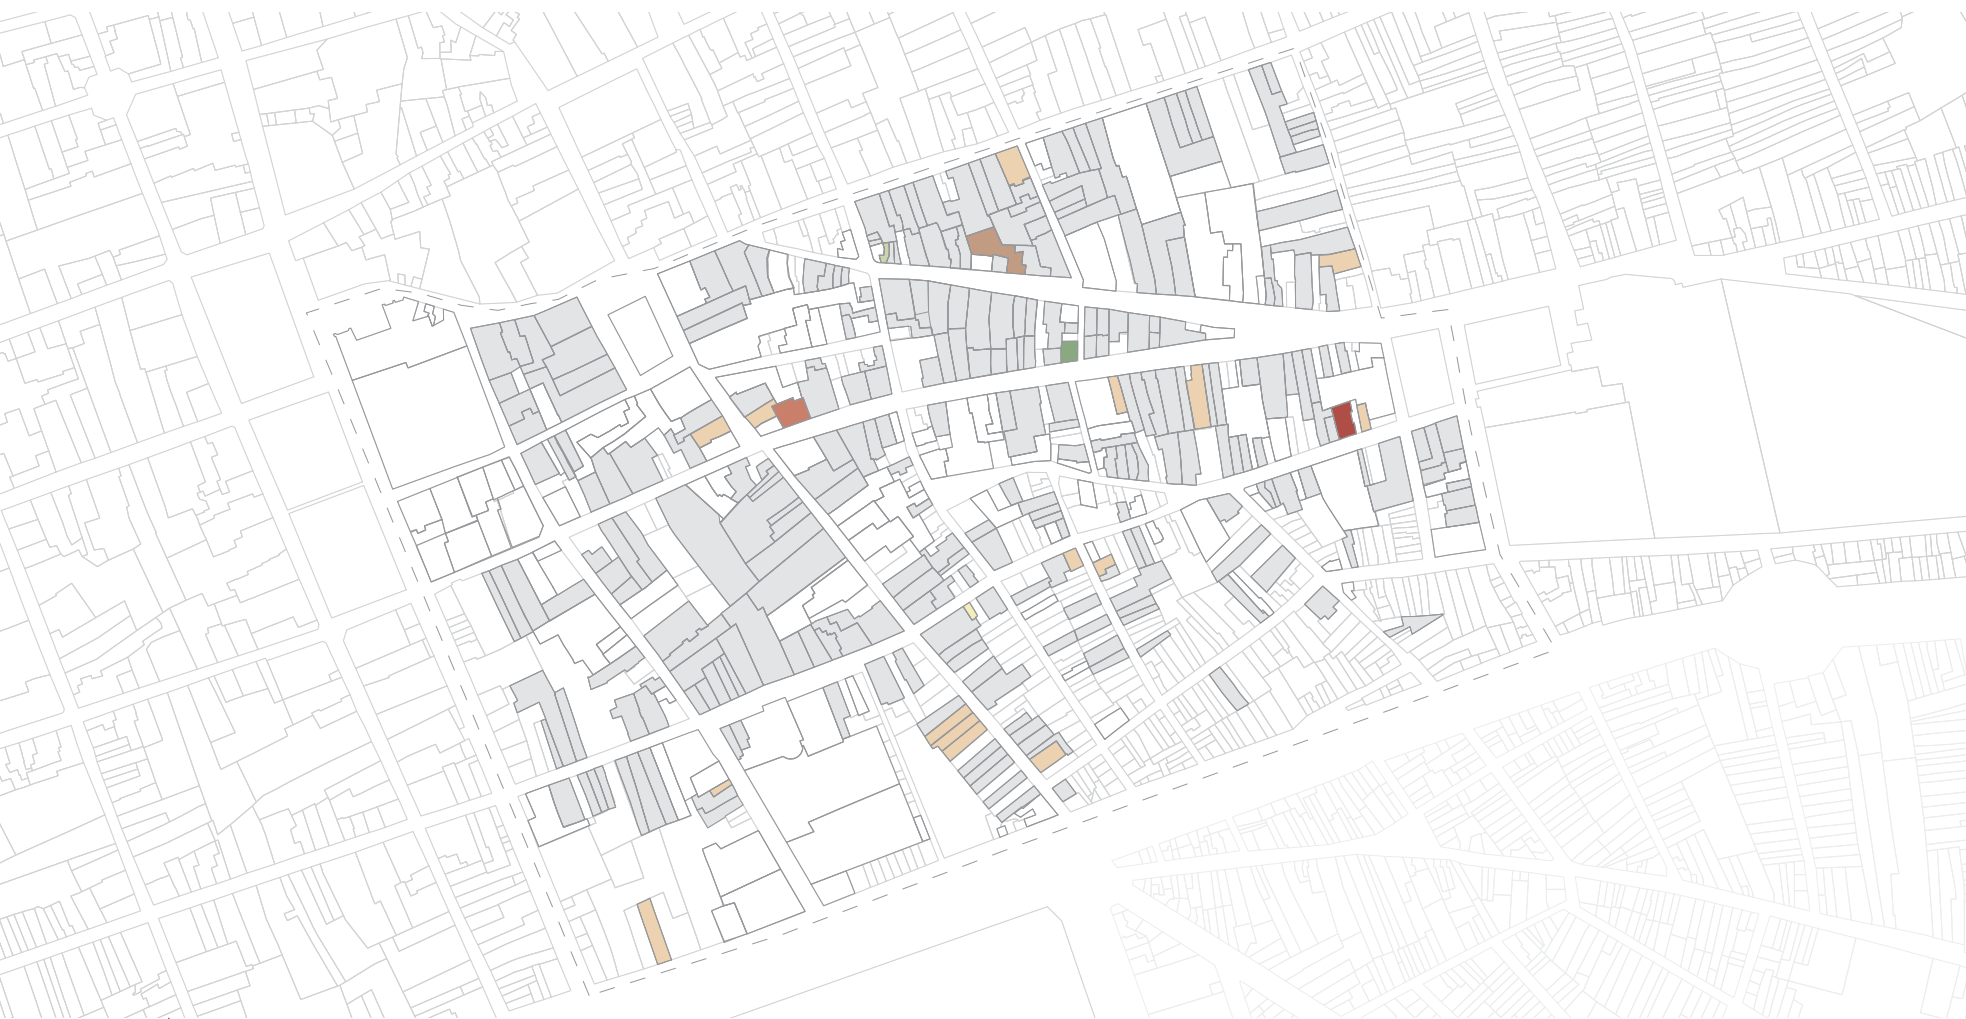
map 25. type of change of attribute; windows
1:5000

In total 25 changes have occurred in 21 houses out of 298 studied ones (7%). In five houses the change has taken place between 1990 and 2000, in 14 between 2000 and 2013 and two in both periods. The most occurred change is the change of a window into door that has happened in 17 cases. Other types of change are when a window has been added (four cases) or removed (three cases) or altered (one case).
