The authenticity and integrity of the Historic Monuments Zone of Querétaro

**Cultural Heritage and Sustainability:
Querétaro as case study**

Research as part of the graduation studio 'Cultural Heritage and Sustainability: World Heritage cities as case study', as part of a research on sustainable development, carried out by the AUDE Unit (Architectural Urban Design and Engineering) of the Eindhoven University of Technology (TU/e).

Historic Monuments Zone of Querétaro, Santiago de Querétaro, Mexico

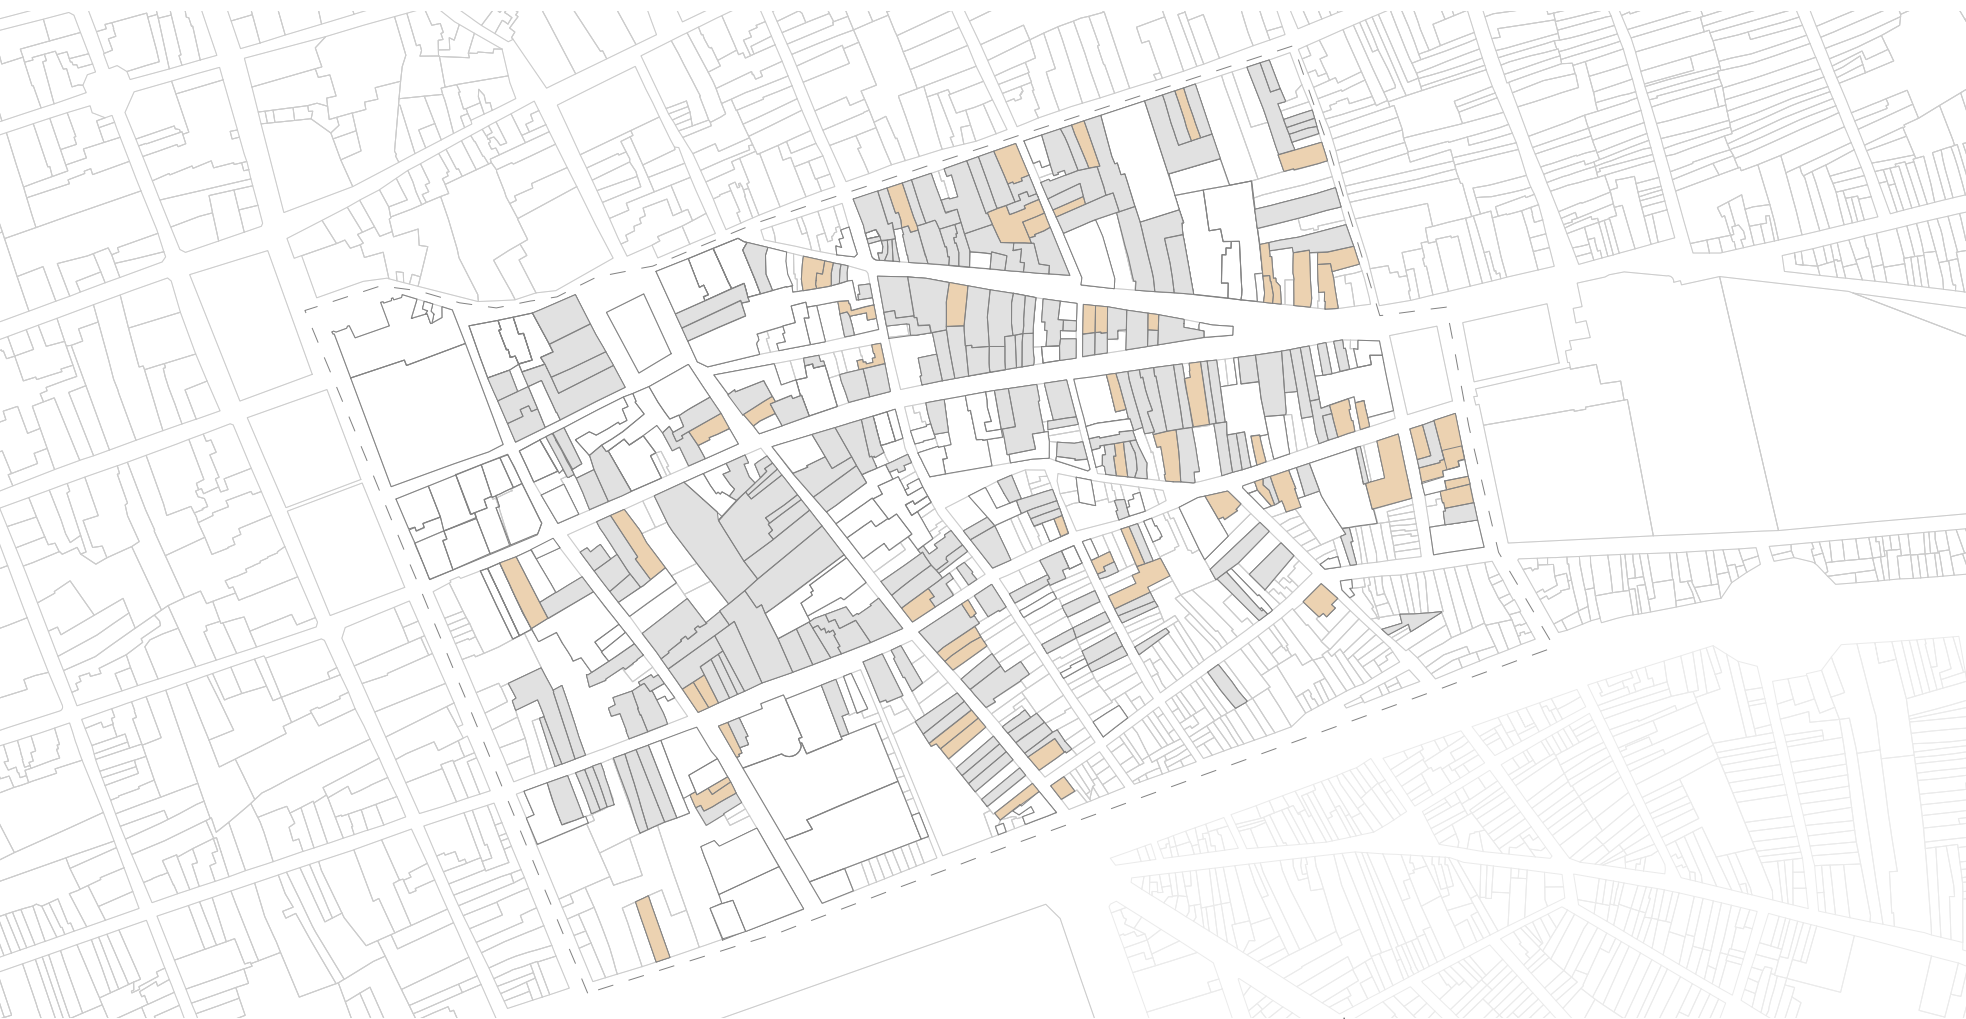
In map 26 the outcome of a comparison between the map of amount of windows in 2013 and the ideal state of the windows, reveals that of all 297 buildings with window as an attribute, 62 do not correspond to the typology descriptions of which 62.9% are located in the east half of the research area. Of those 62 buildings, 16 have presented a change in the amount of windows at least once between 1990 and 2013.

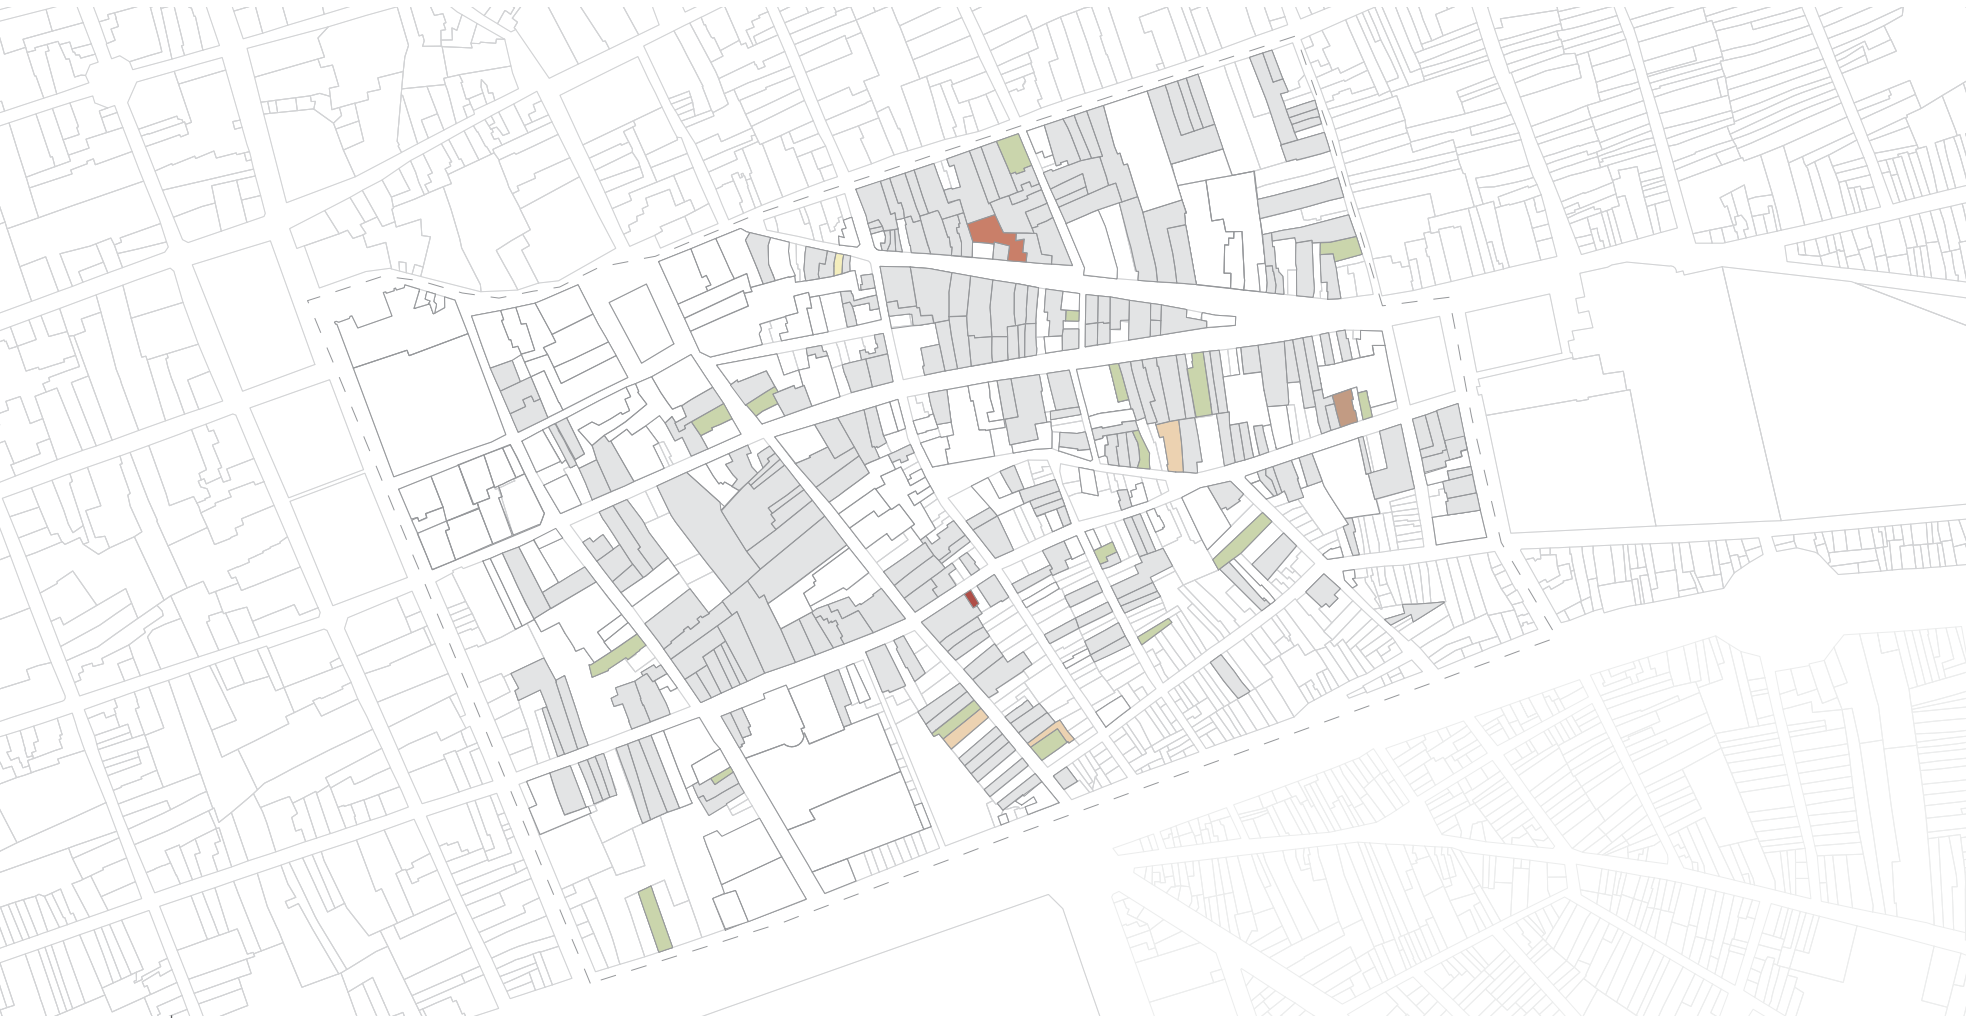
map 36. type of change of attribute; door and window frameworks

A comparison among the state of the frameworks in different years reveals the changes that have taken place in the opening frameworks in the buildings over time. In total of all 279 houses possessing this attribute, 29 (10.4%) have presented a change in one or more frameworks. Of those changes, six have occurred between 1990 and 2000 and 21 between 2000 and 2011. The other two are in both periods. In 29 houses presenting a change in their frameworks,

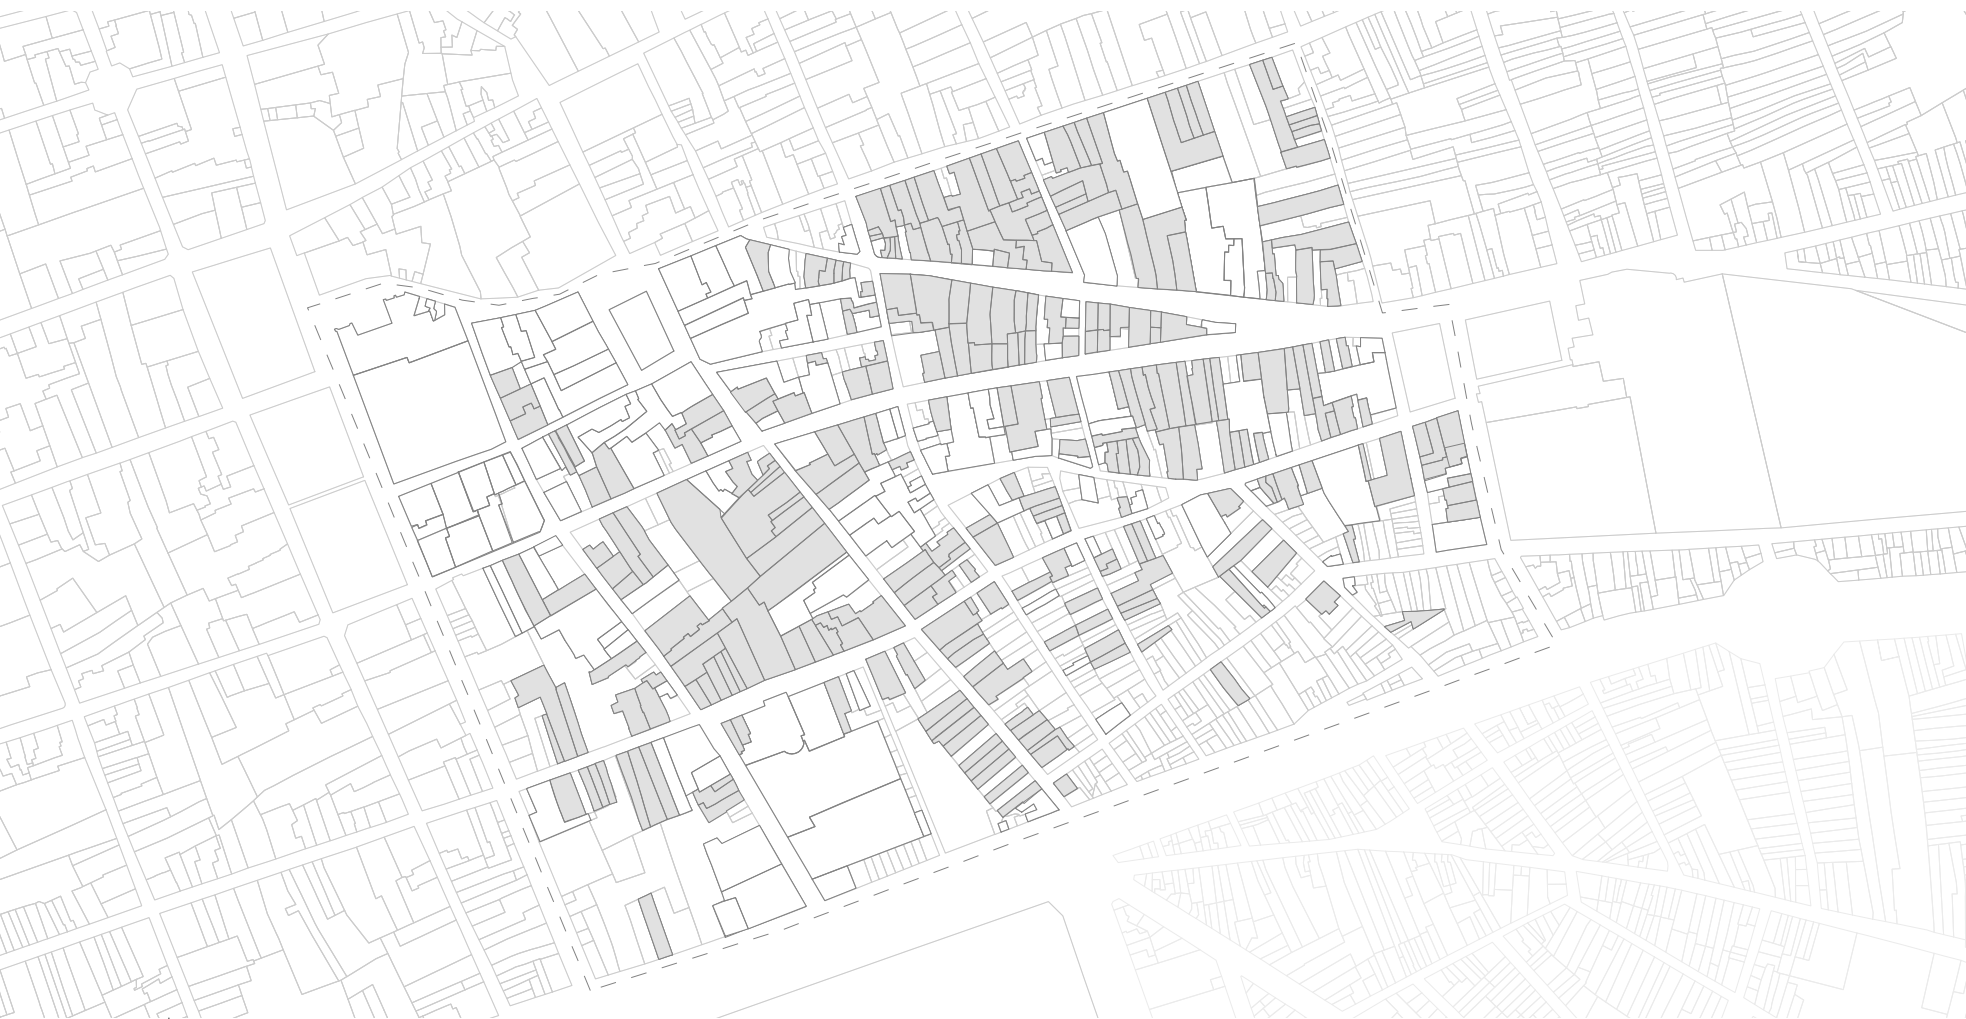
map 37. typology fit; frameworks
1:5000

Comparing the state of the frameworks in 2013 with the typology map shows that in all the buildings the attribute is still present and therefore all the buildings fit the typology description on this attribute.

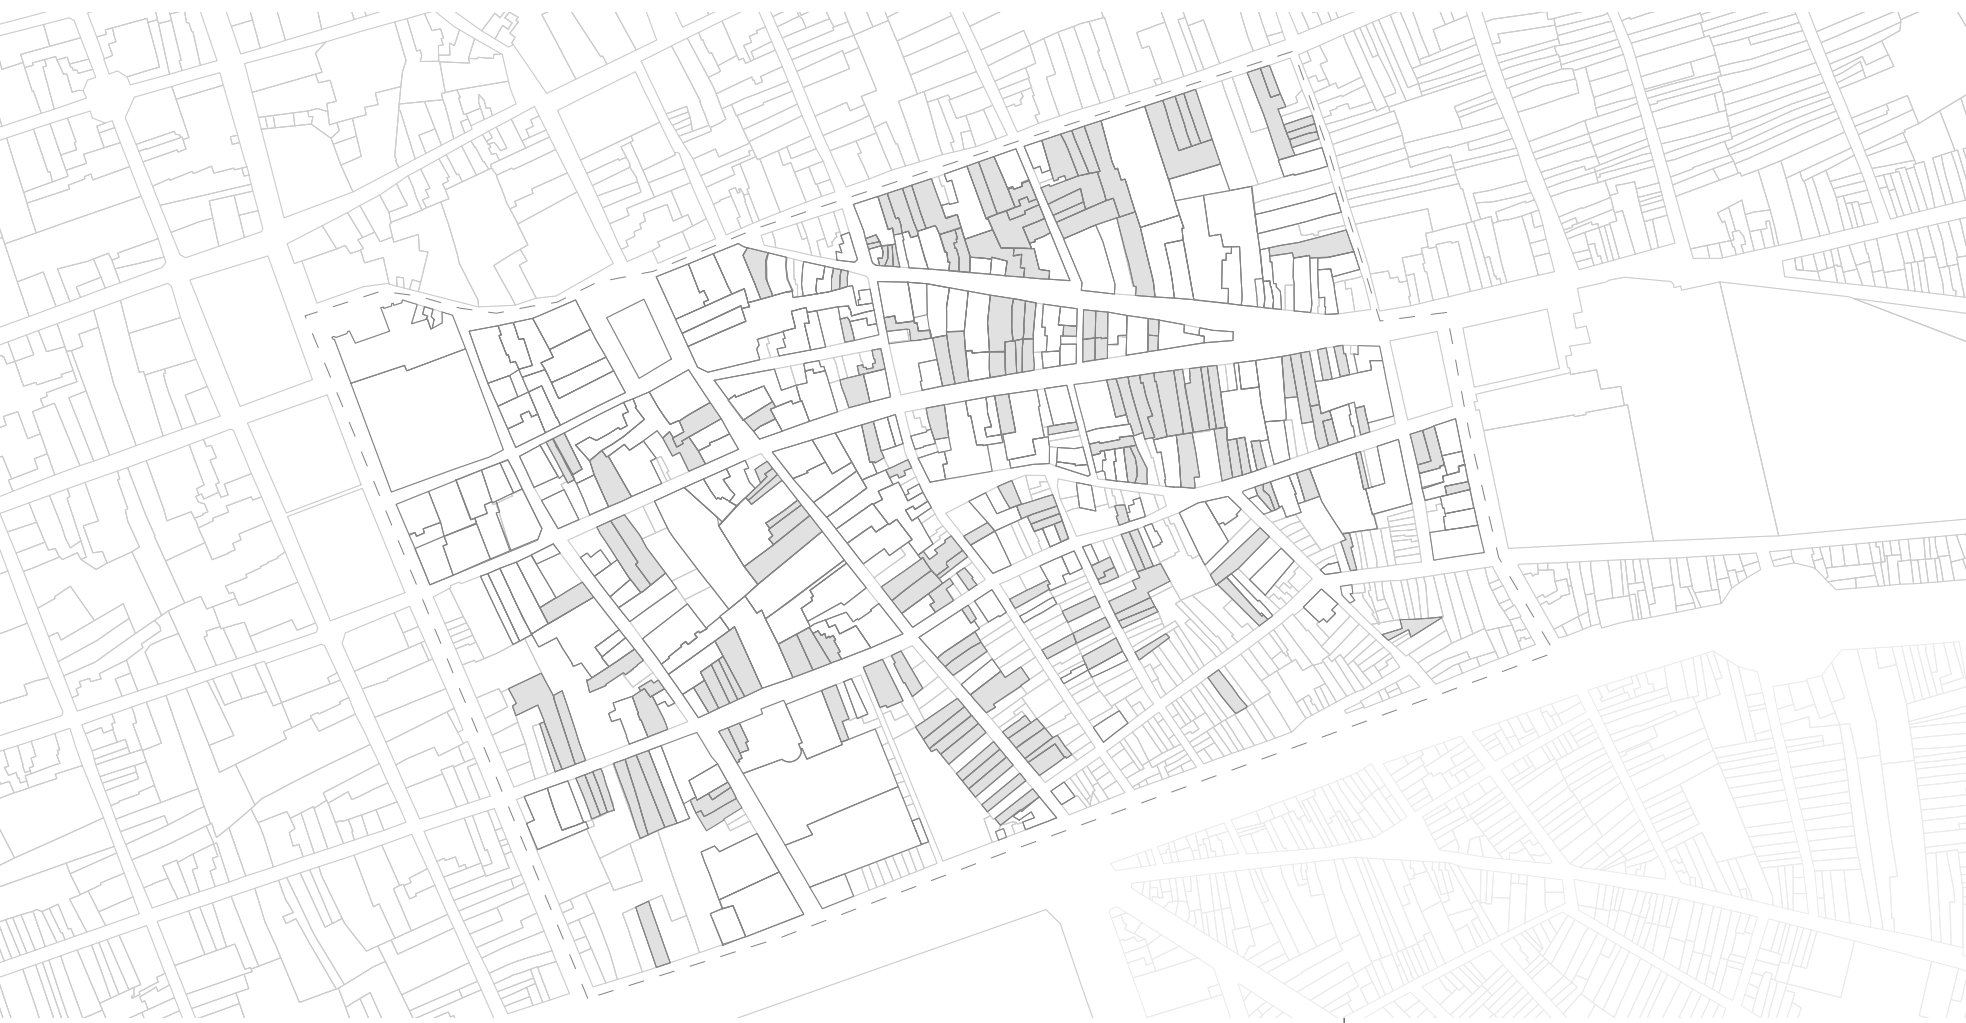
As it is shown in map 42, there is no change in presence or amount of cornices around the openings in the studied buildings between 1990 and 2013.

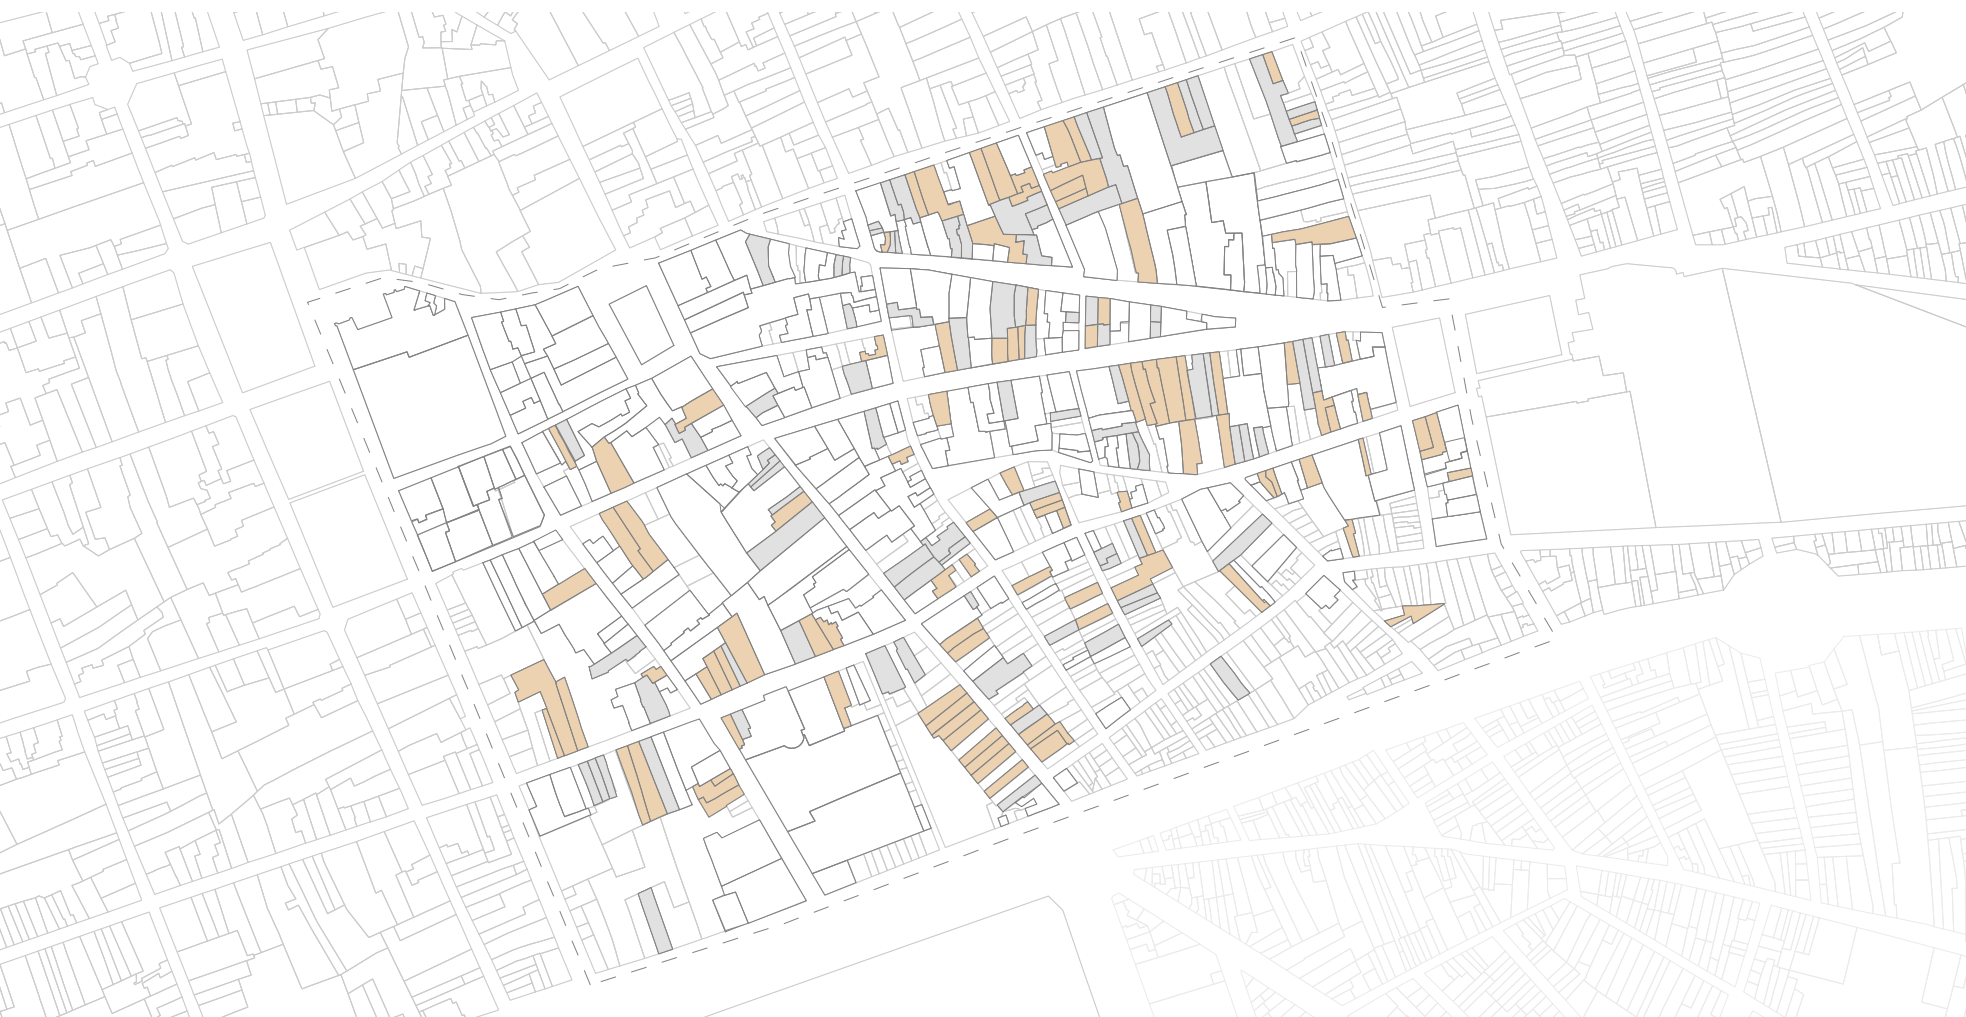
map 43. typology fit; door cornices
1:5000

Comparing the state of the cornices in 2013 with the ideal map shows that in more than half (53.9%) of the studied buildings possessing this attribute, the state of the cornices differs from the description in building typology.

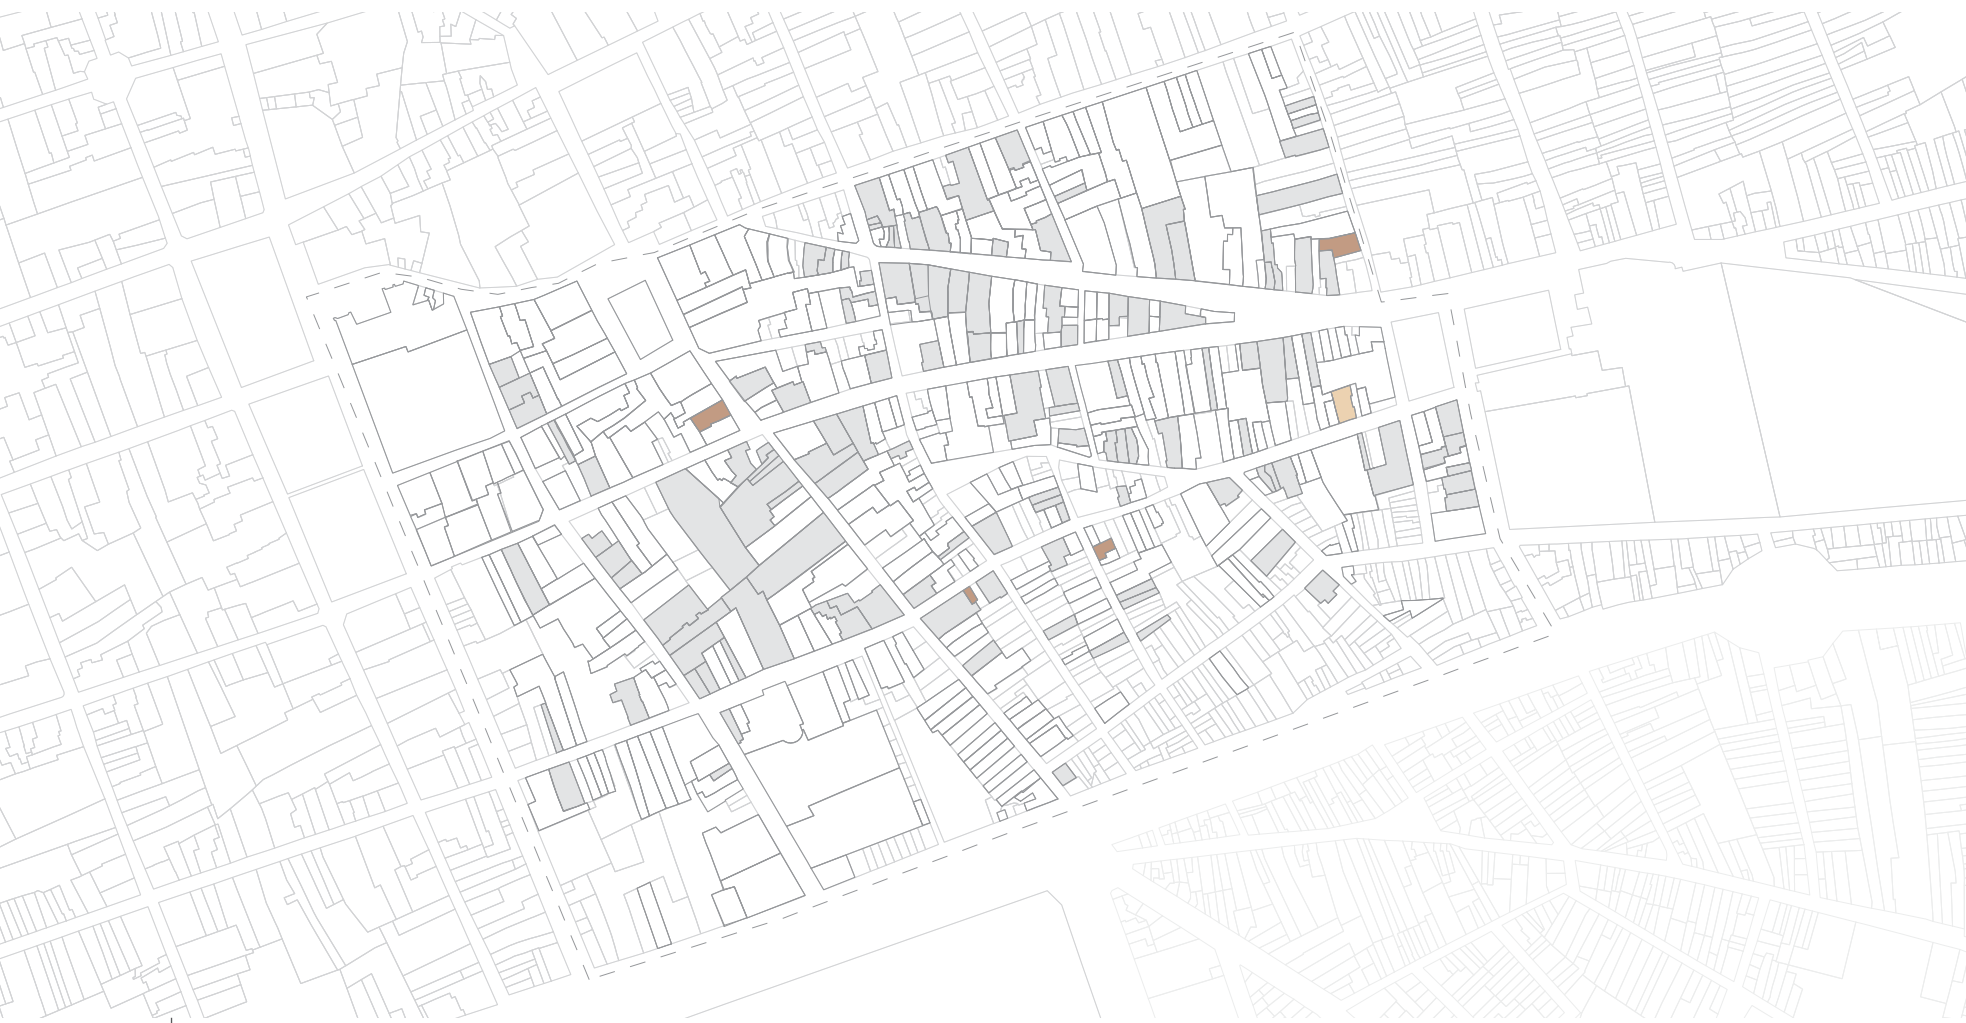
map 49. type of change of attribute;
window railings

Between the years 1990 and 2013, among all 128 buildings that have window railings as an attribute, in only five cases the window railings have changed (3.9%). Two of the changes have occurred between 1990 and 2000 and three between 2000 and 2013. The railings are either removed (four cases) or added (one case).

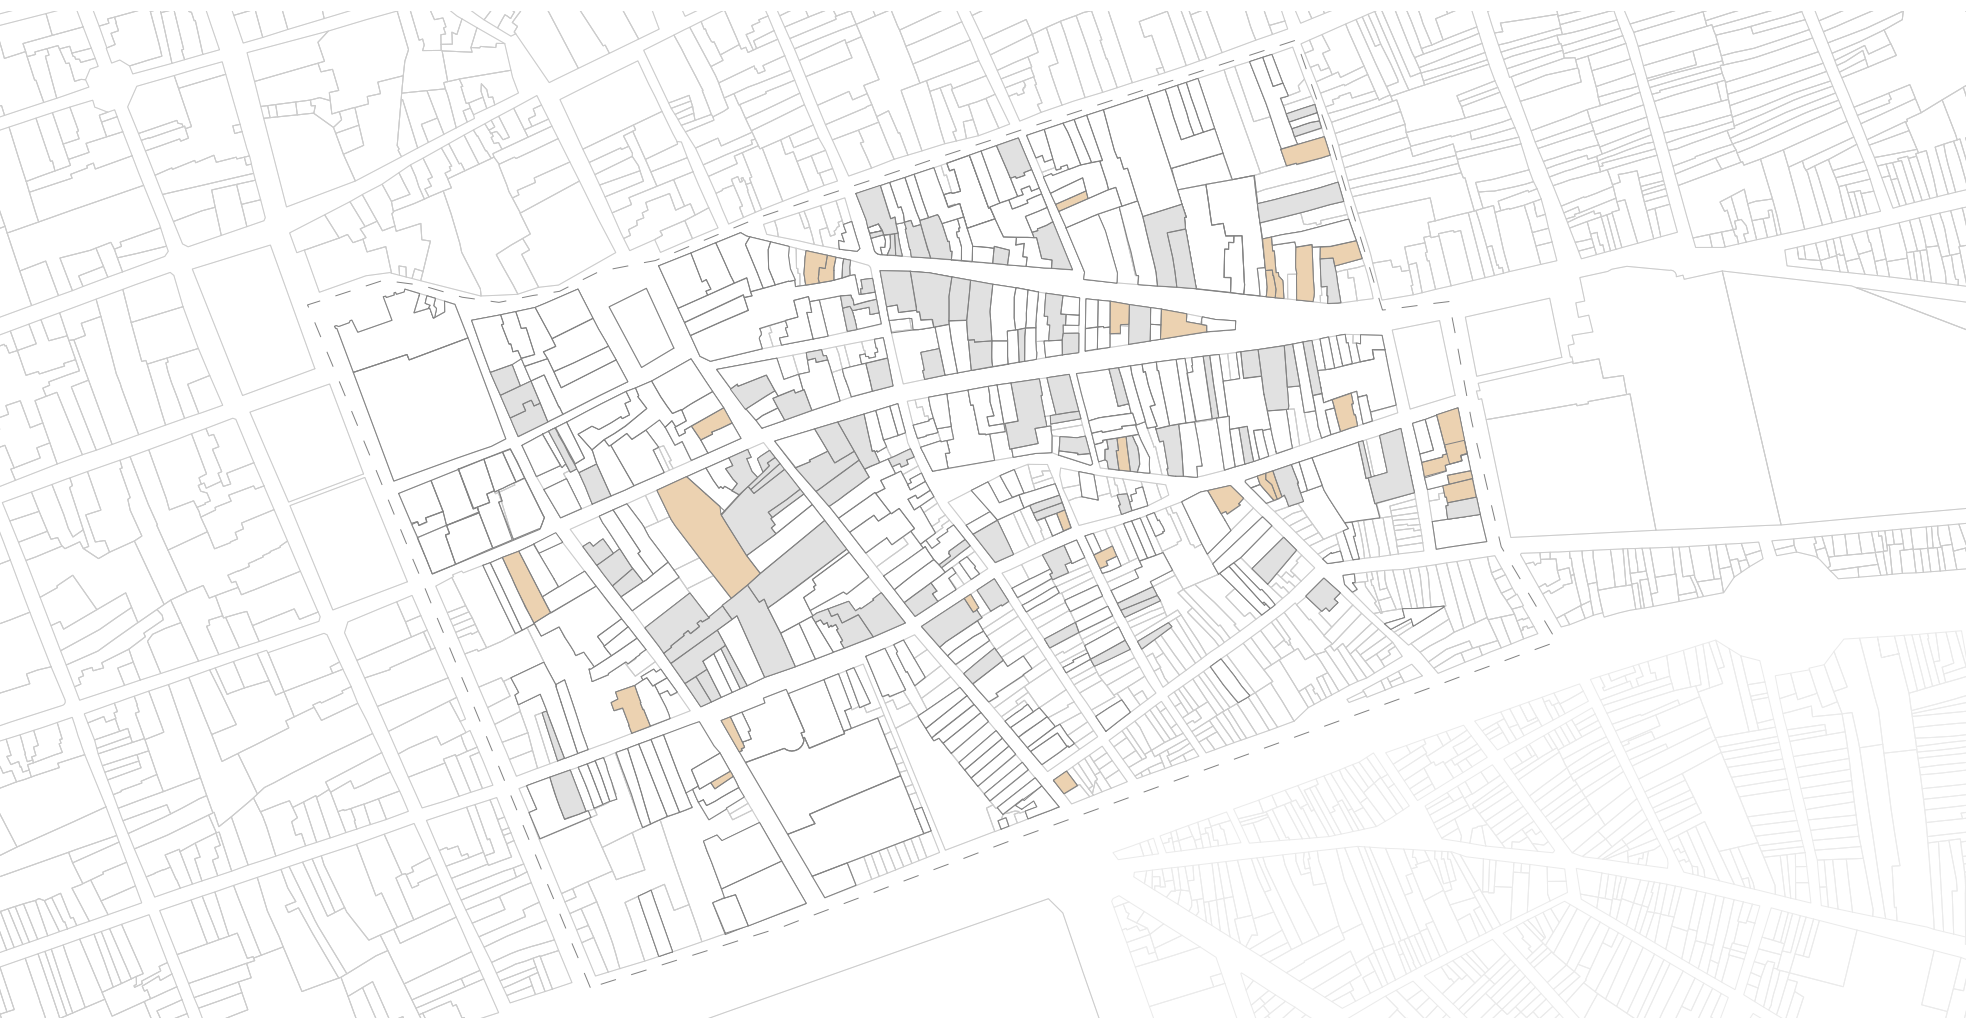
map 50. typology fit; window railings
1:5000

Of all 128 studied buildings for this attribute, 28 do not present window railings according to the typology description and therefore they do not fit the typology. Almost two third (64.3%) of these buildings are in the east half of the area.

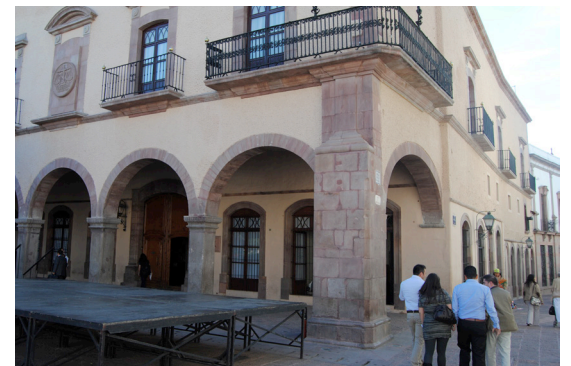
figure 26. Example of a catalogued building with portals, sector G

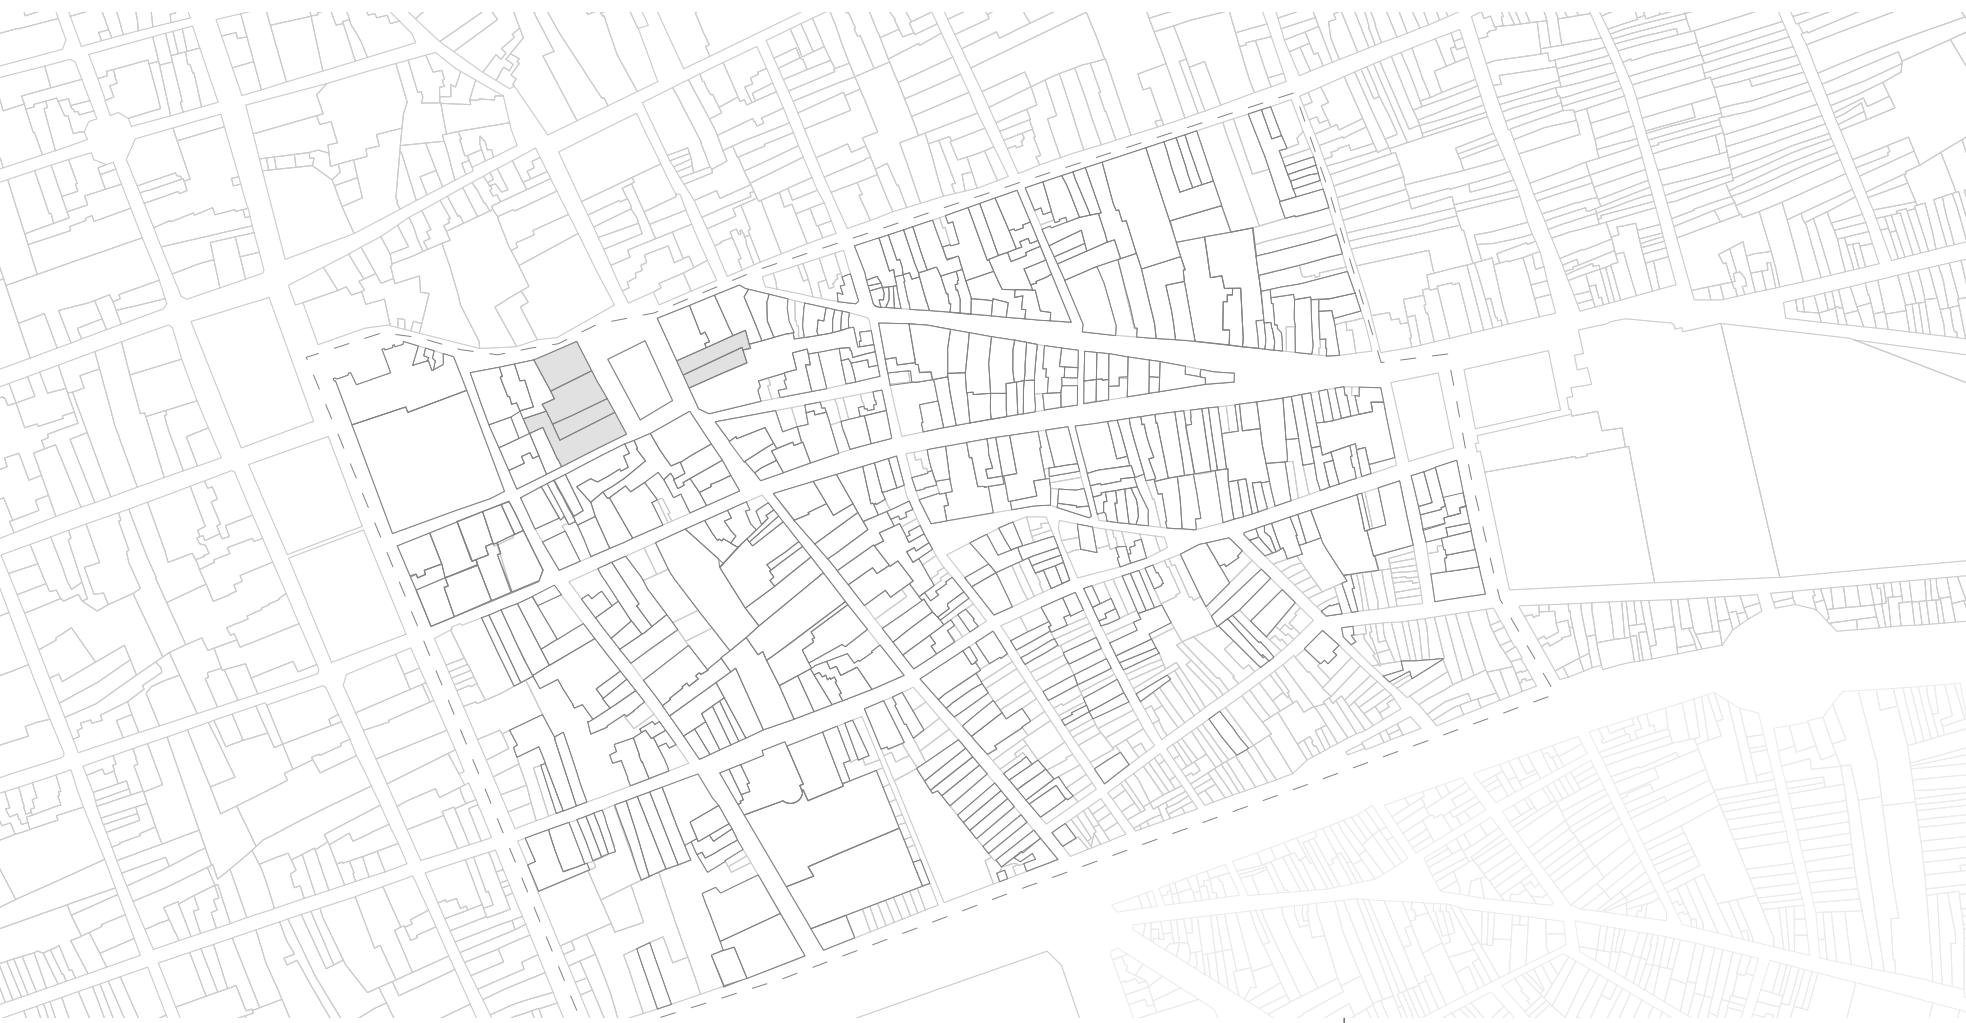
Comparing the state of the portals in the buildings between 1990 and 2013 reveals no changes in the presence or amount of the portals.

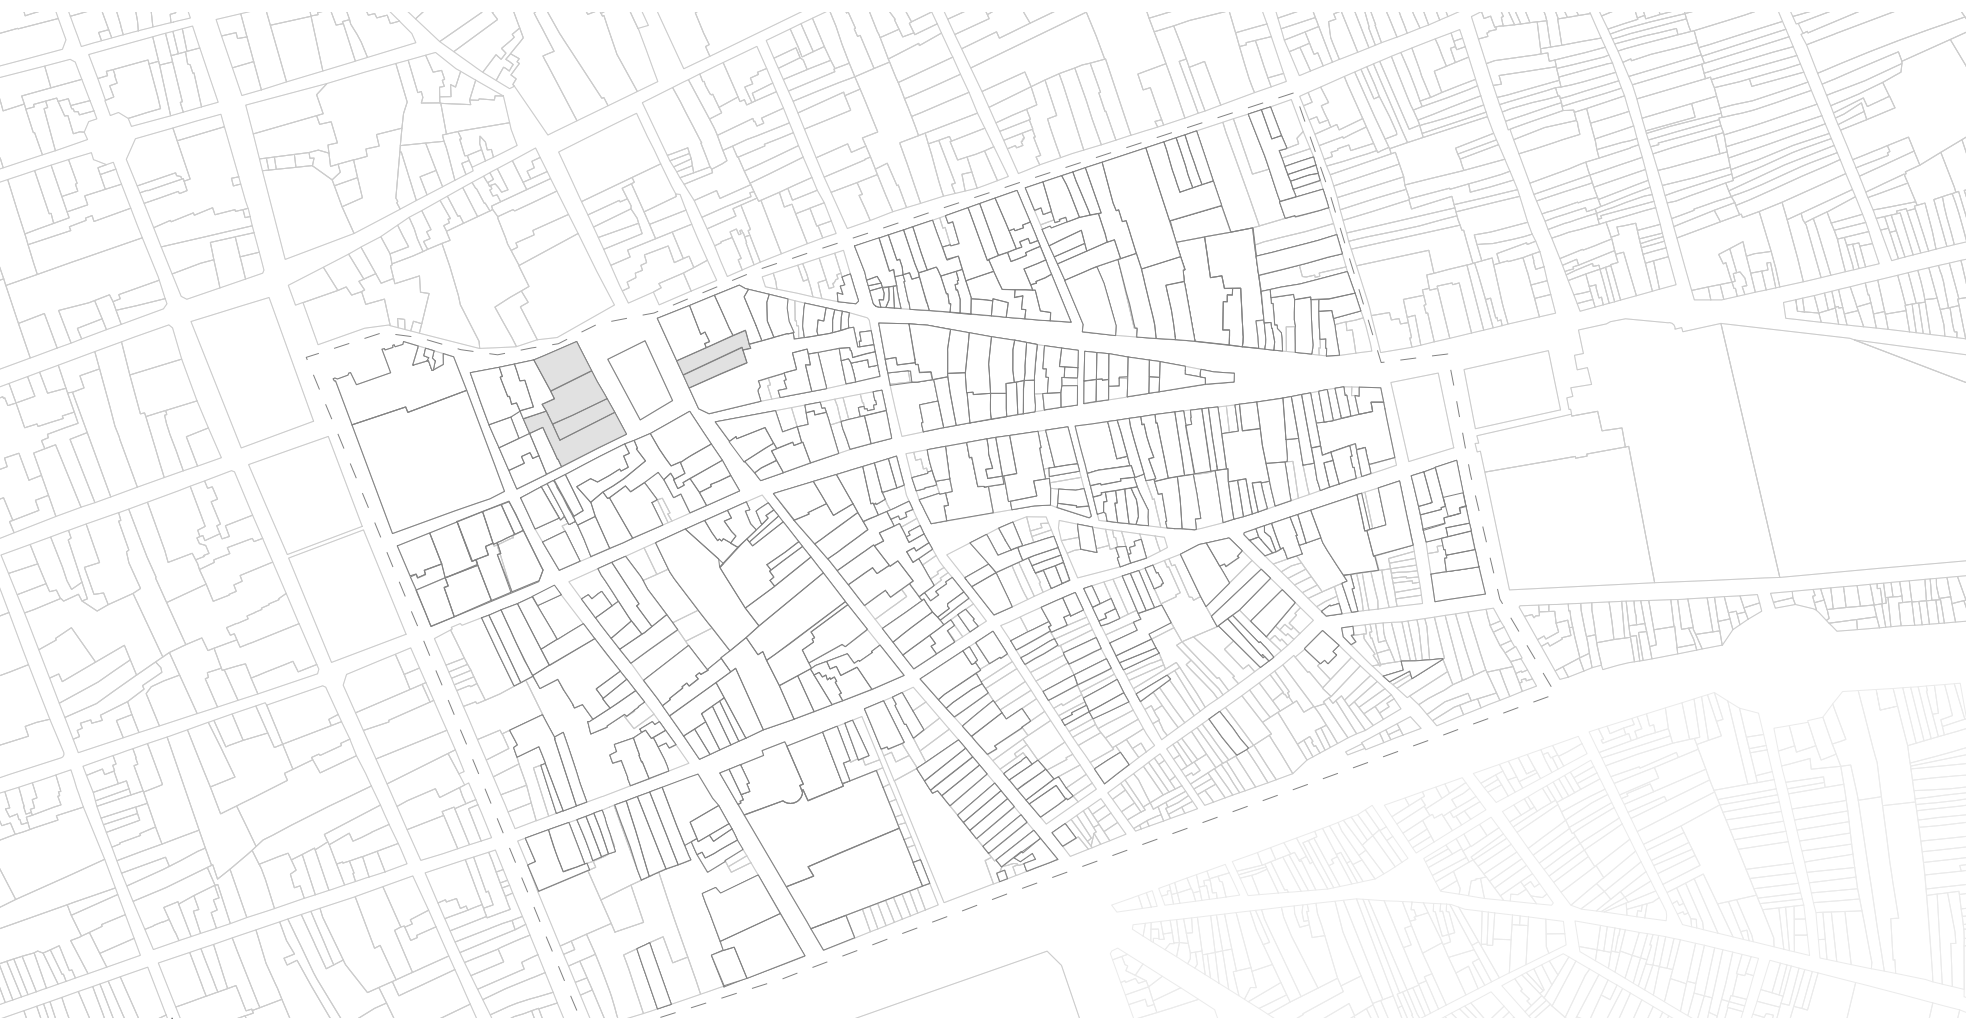
map 56. typology fit; portals
1:5000

Comparing the actual state of portals in 2013 with the ideal map shows that all the portals are still present in the buildings with portals as an attribute.

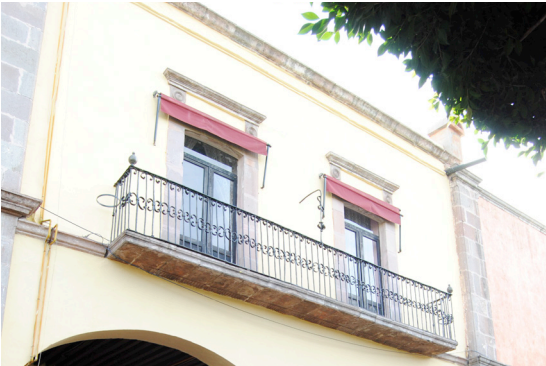
figure 27. Example of a catalogued building with balconies, sector G

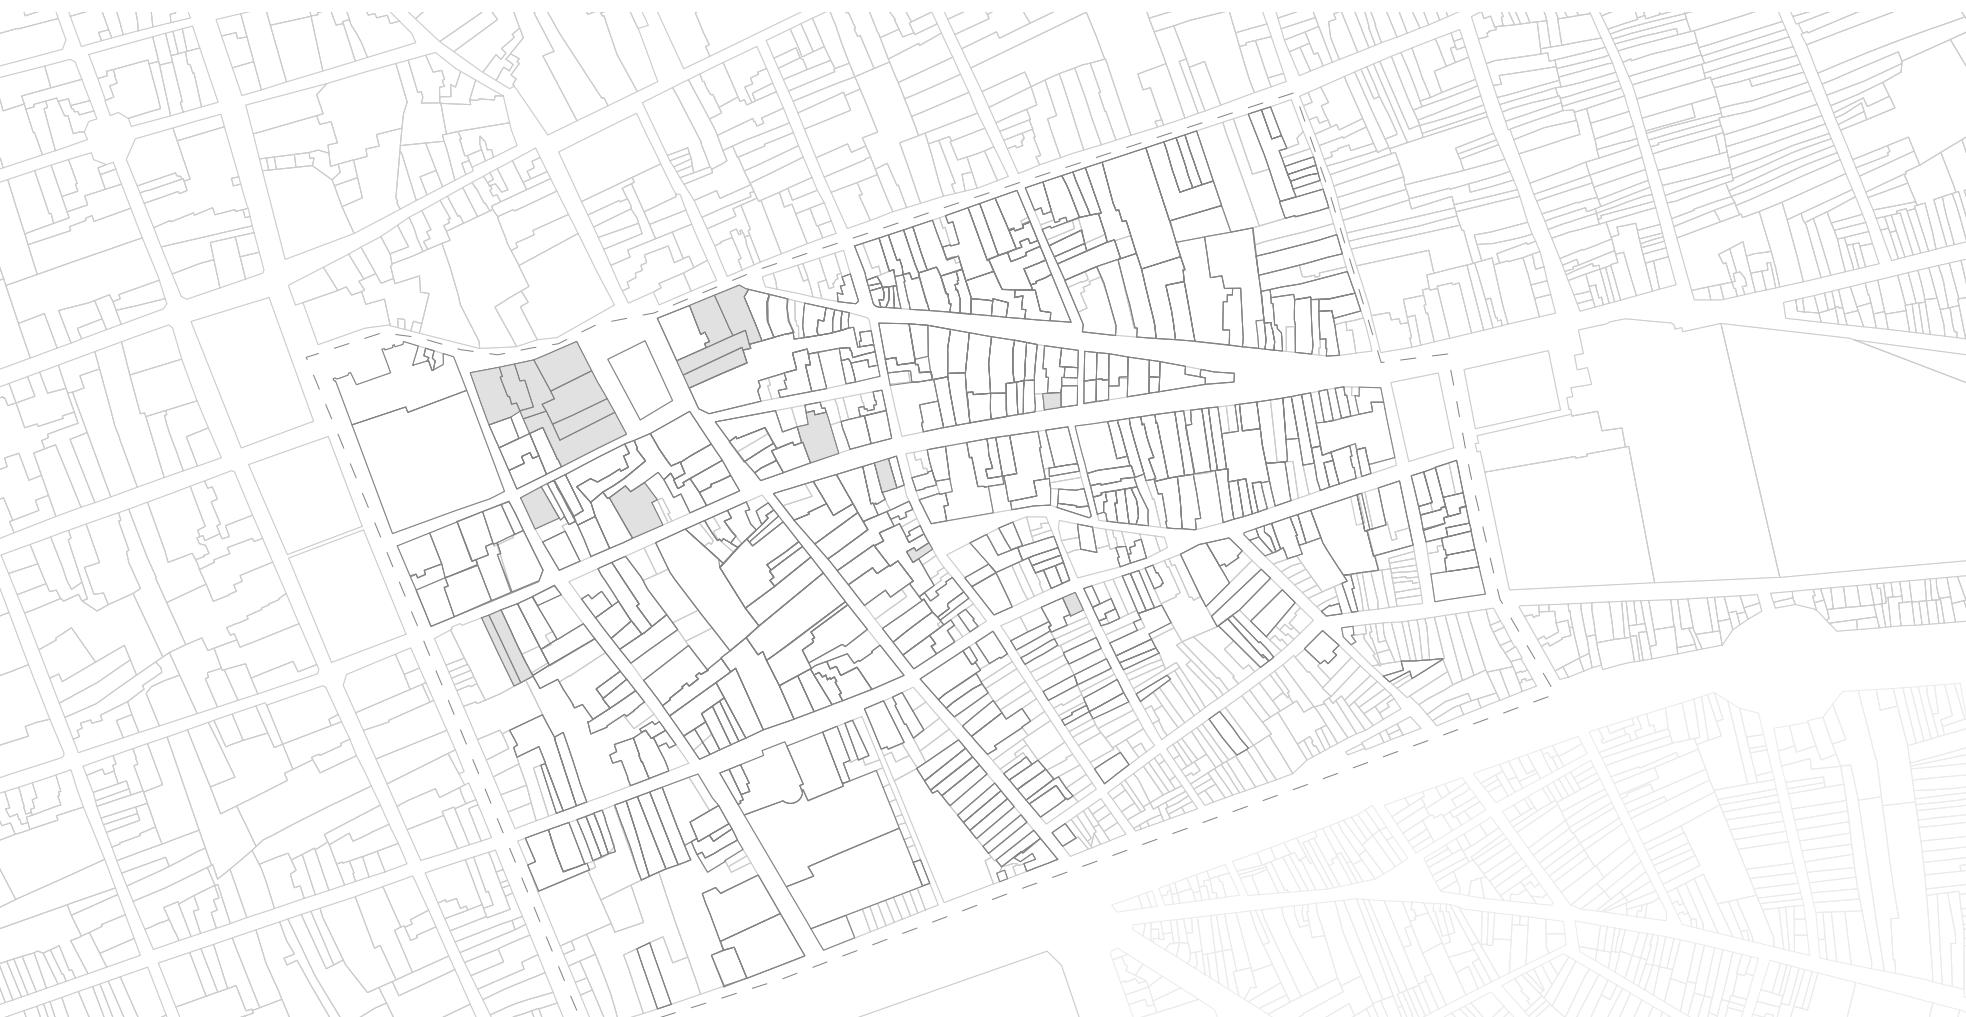
Changes in attribute: balconies

The map on changes in balconies (map 61) aims to show the authenticity of the original balconies present in the research area. Of the houses that originally presented a balcony on their main façade, all still have their balcony. No balconies have been added or removed between 1990 and 2013 and this attribute is still present in the research area.
