The authenticity and integrity of the Historic Monuments Zone of Querétaro

**Cultural Heritage and Sustainability:
Querétaro as case study**

Research as part of the graduation studio 'Cultural Heritage and Sustainability: World Heritage cities as case study', as part of a research on sustainable development, carried out by the AUDE Unit (Architectural Urban Design and Engineering) of the Eindhoven University of Technology (TU/e).

Historic Monuments Zone of Querétaro, Santiago de Querétaro, Mexico

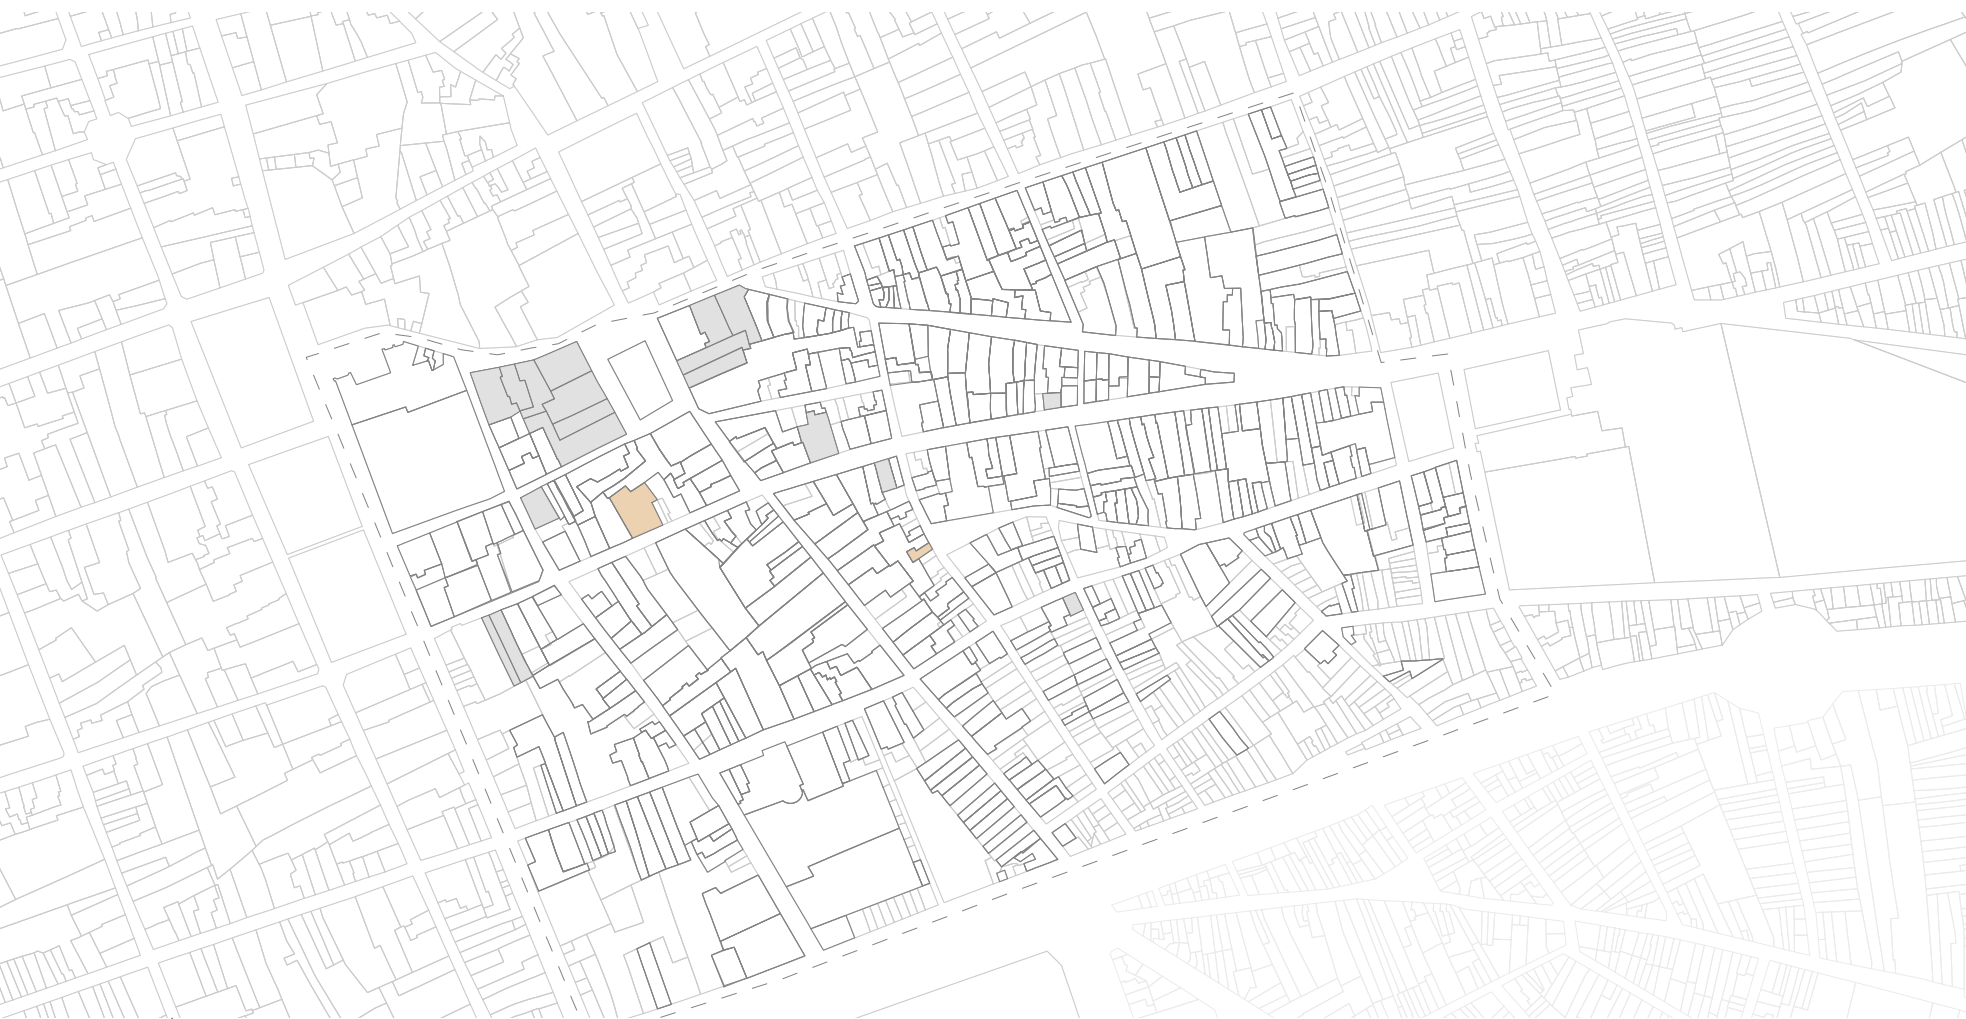
map 62. typology fit; balconies
1:5000

There are two buildings in the studied area (10%) in which the state of the balcony in 2013 is different from the description. None of the non-corresponding buildings has presented a change in the amount of balconies over time.

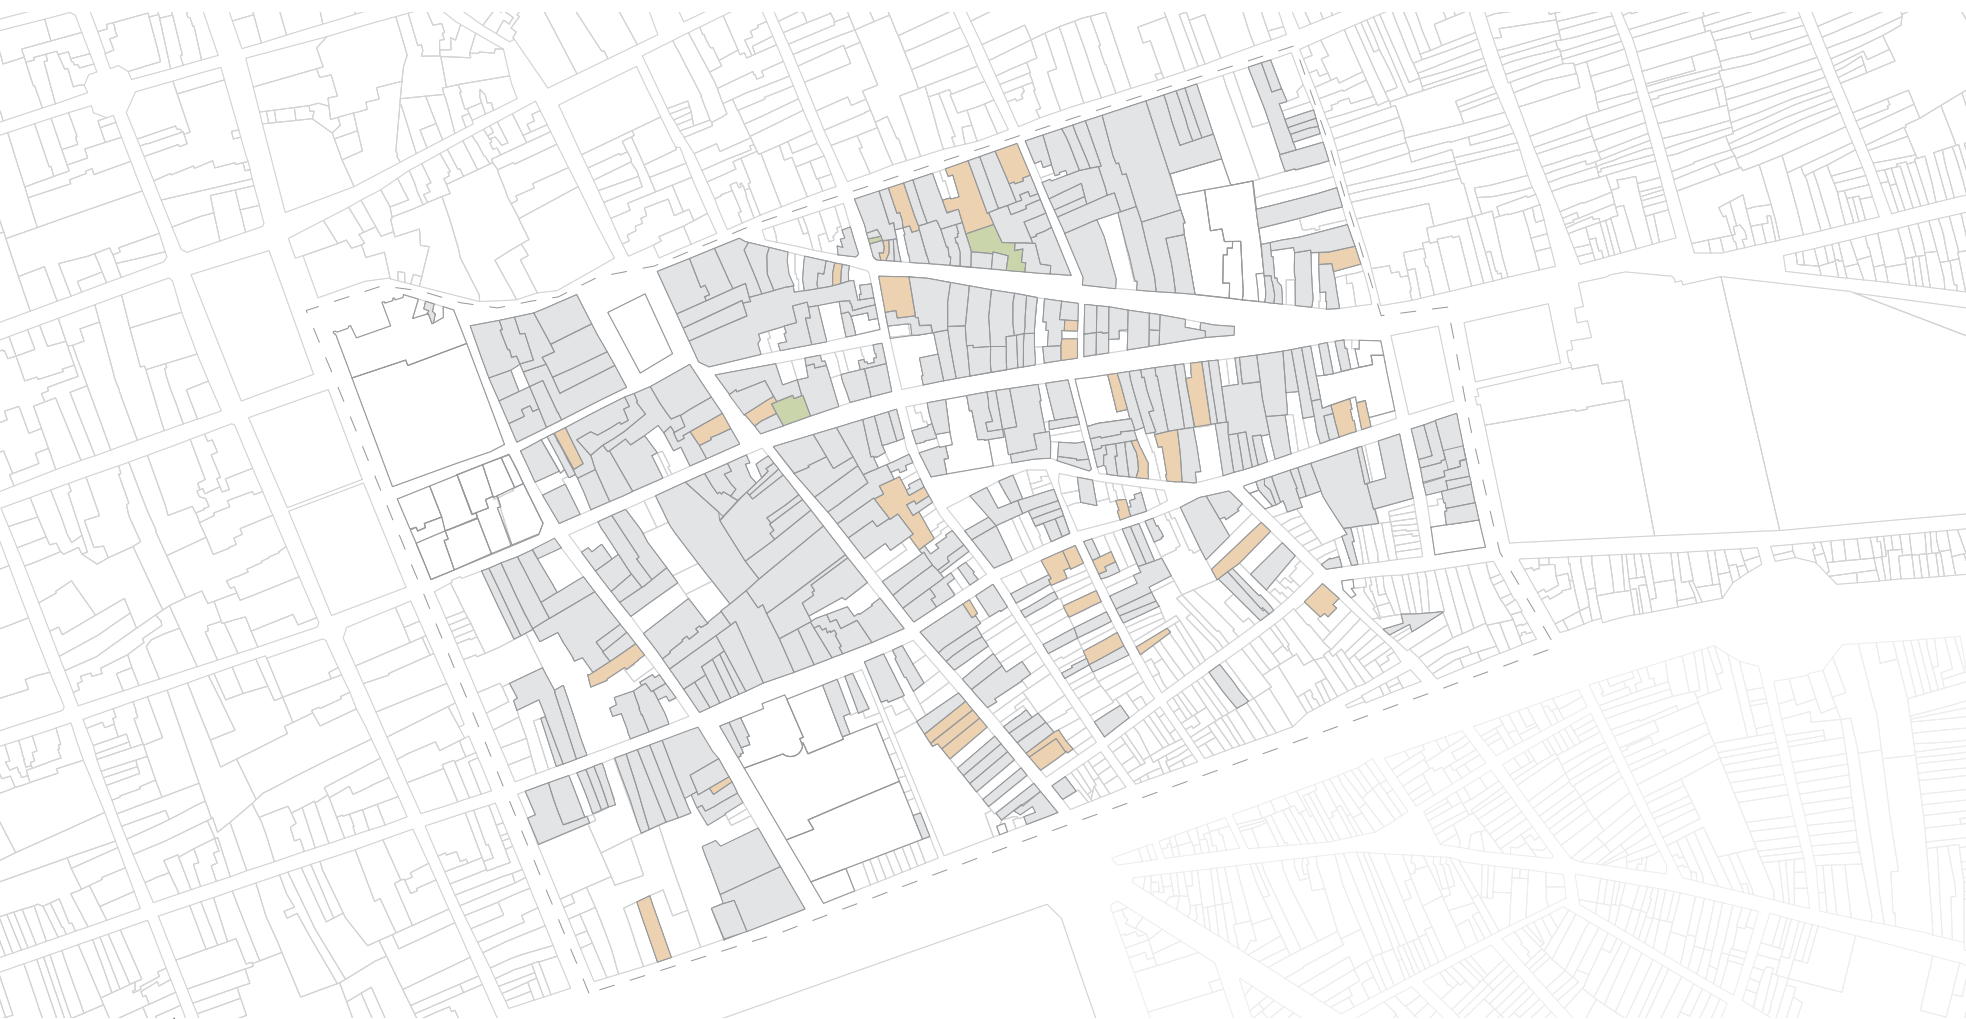
1:5000

Earlier in this chapter, eight attributes were studied separately and the changes in the buildings were analyzed. The maps in this part are generated as the conclusion of all separated attributes in order to have an overview of how the buildings, conveying one or more of those attributes, have changed over time. Whenever at least one attribute in the building has changed over time, the building is marked as changed.

map 64. Facade attributes, type of change

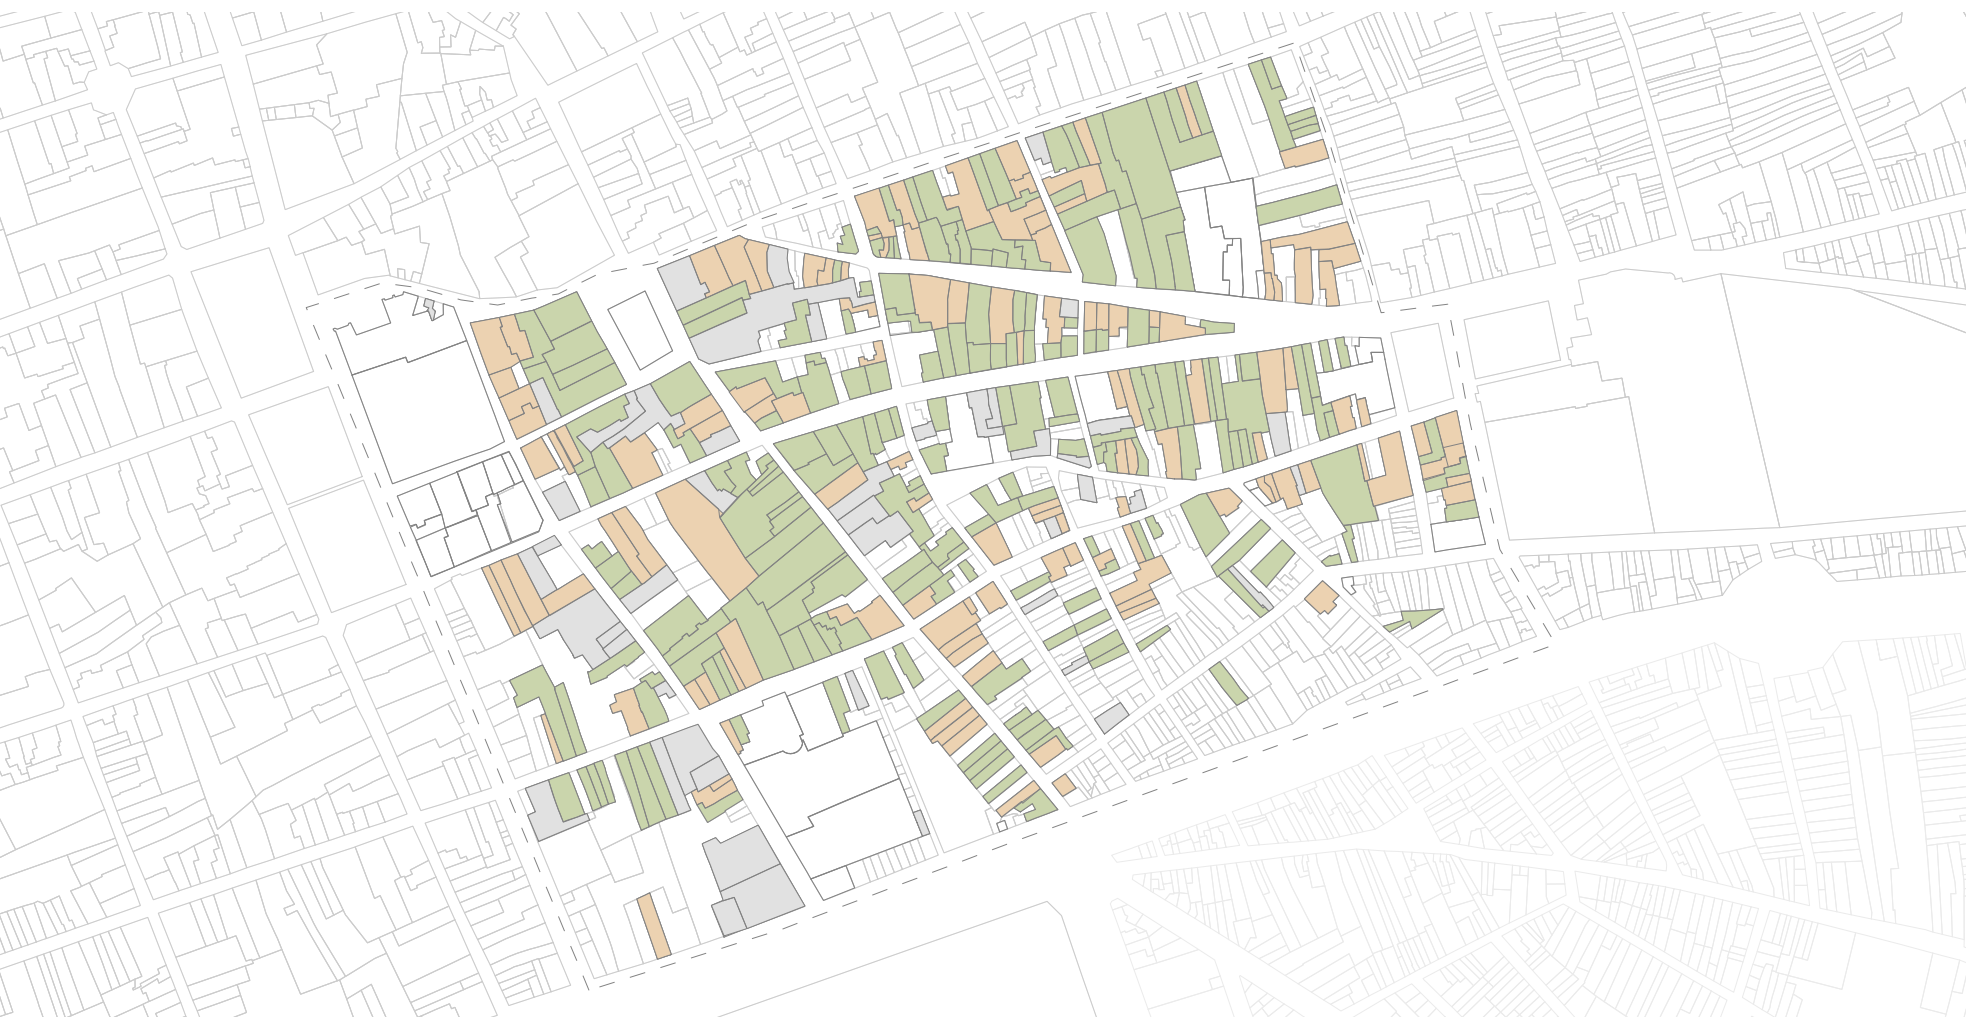
Typology comparison: all attributes

Map 65 shows the buildings that still correspond to the typology. Whenever there is at least one changed attribute in a building, then that building is colored as not having all its defined attributes present and therefore not corresponding to the typology. Among those 335 houses, 202 (60.3%) still have all their defined attributes present in 2013. In 133 houses (39.7%), at least one of the attributes has been changed over time.

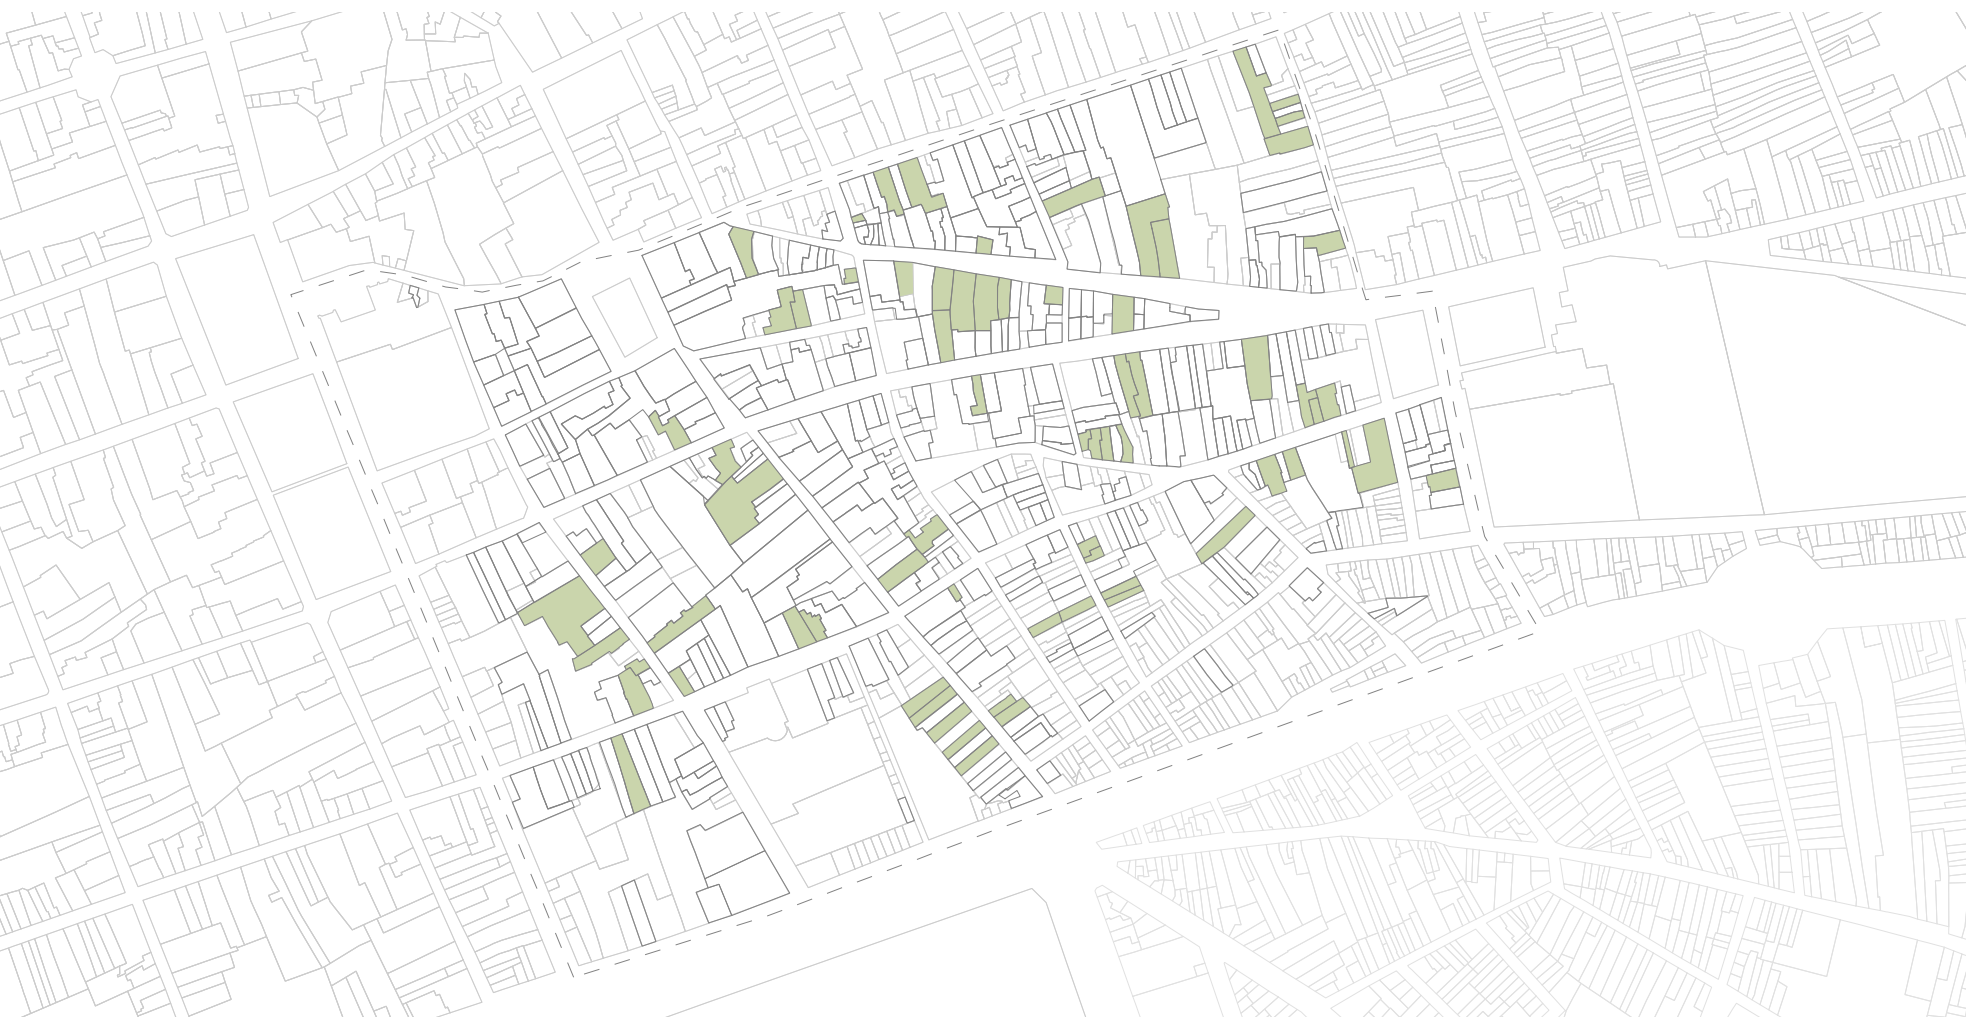
map 73. Originally residential
uses, 2011, sector G
1:5000

Map 73 is generated to give an overview of the buildings that in 2011 still keep their original use. It shows that out of 374 buildings with the original residential buildings, 195 (52.1%) are still residential and are mostly to be found on the east half of the area.

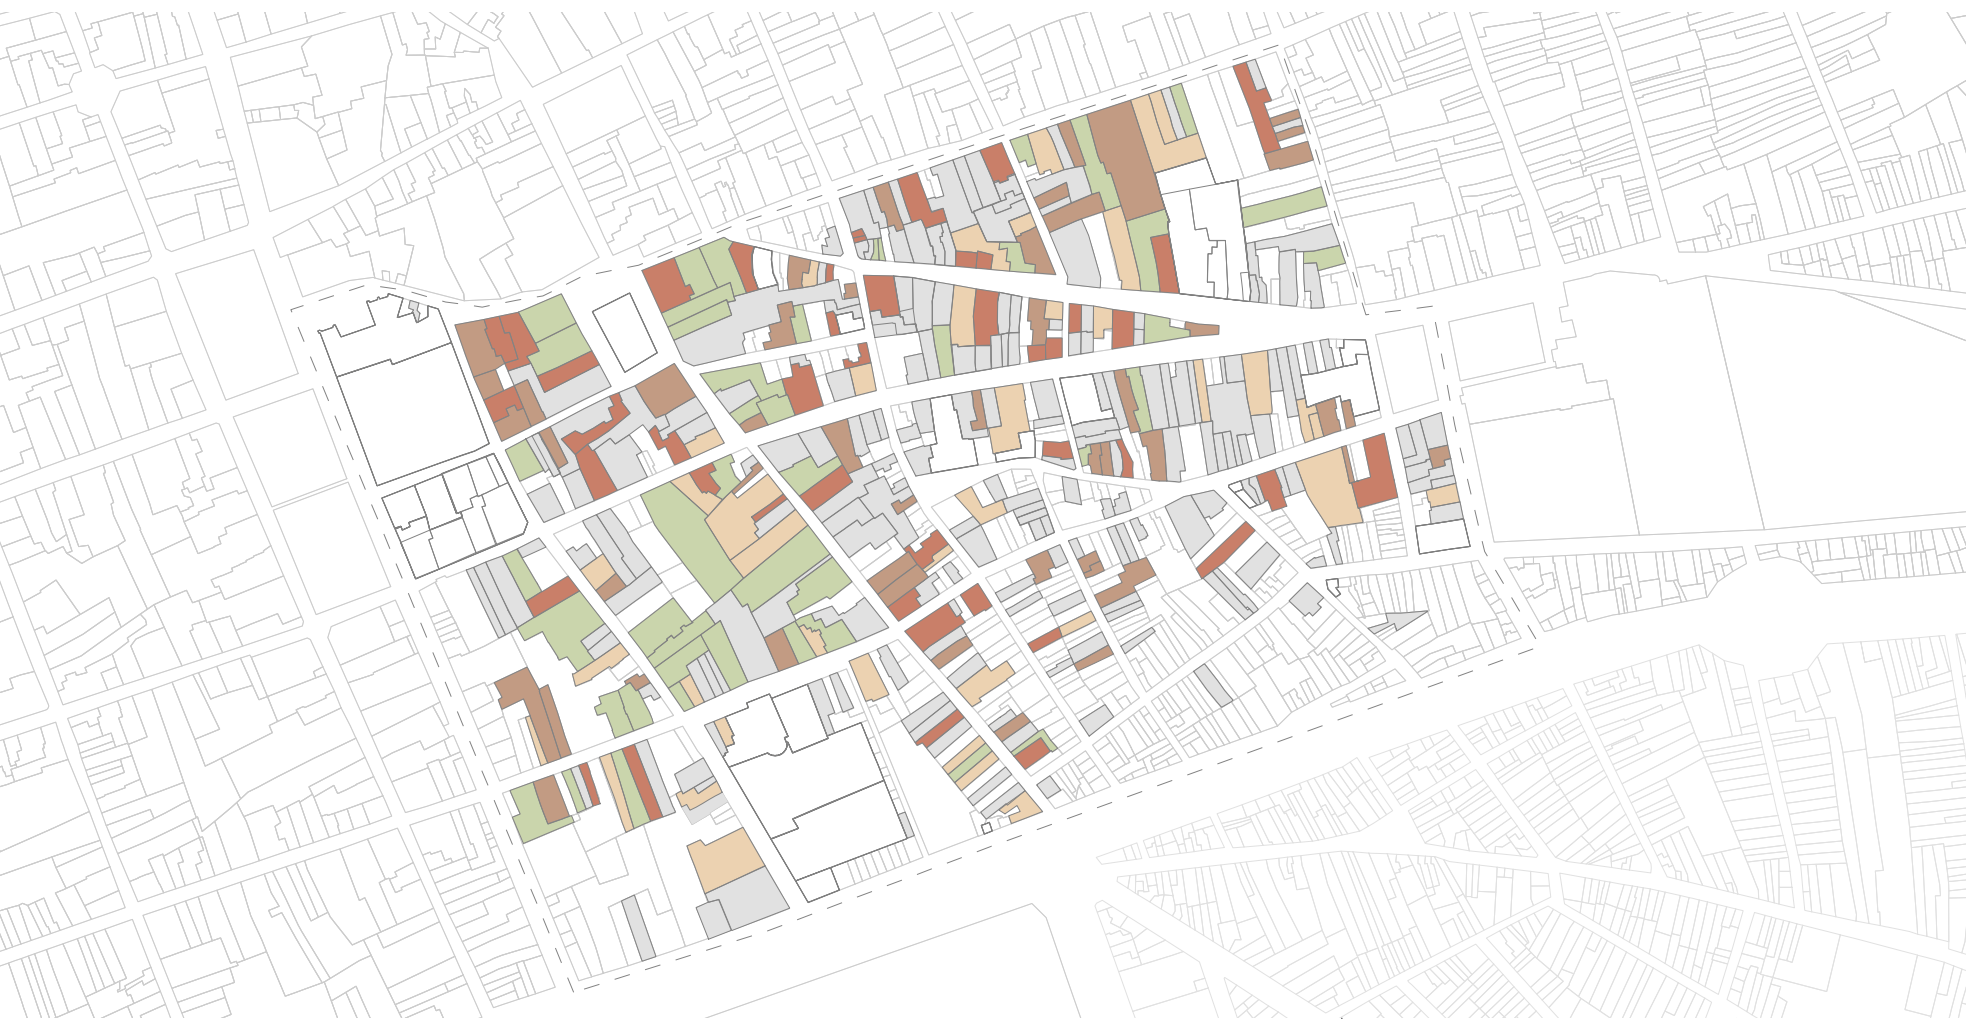
Changes in state of conservation

Map 77 shows the results of a comparison between 1990 and 2011 in the state of conservation of the studied buildings. Between 1990 and 2000 the condition of 49% of the buildings has either improved (33%) or deteriorated (16%). The rates of the improvements and deteriorations between 2000 and 2011 are 22.1% and 30.1% respectively.
